General Information
(see reverse for instructions)

Name of Project	Franklin Hills Estates & Country Club	CGP Tracking No.	IR #20-10	Inspection Date	1/4/2021
Inspector Name, Title & Contact Information	Inspector: David C. McKay, P.E.		Reviewer: David McKay, P.E.		
Present Phase of Construction	Phase 1				
Inspection Location (if multiple inspections are required, specify location where this inspection is being conducted)	Areas of Concern as defined at site walk with wetlands commission				
<p>Inspection Frequency (Note: you may be subject to different inspection frequencies in different areas of the site. Check all that apply.)</p> <p>Standard Frequency: <input type="checkbox"/> Weekly <input type="checkbox"/> within 24 hours of a 0.5" rain</p> <p>Increased Frequency: <input type="checkbox"/> Every 7 days and within 24 hours of a 0.5" rain (for areas of sites discharging to sediment or nutrient-impaired waters or to waters designated as Tier 2, Tier 2.5, or Tier 3)</p> <p>Reduced Frequency:</p> <ul style="list-style-type: none"> - <input checked="" type="checkbox"/> Once per month (for stabilized areas) - <input type="checkbox"/> Once per month and within 24 hours of a 0.5" rain (f

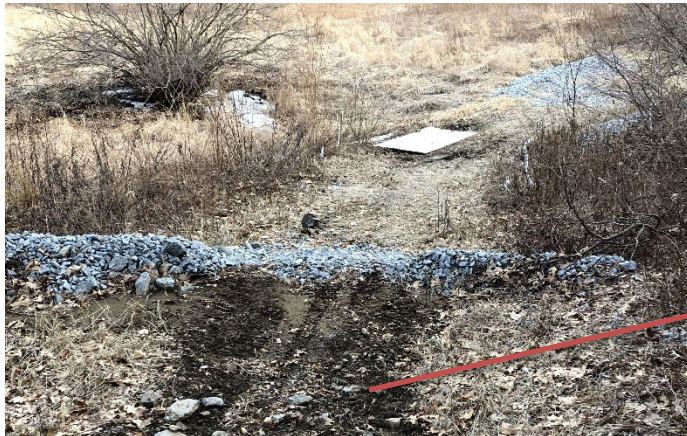
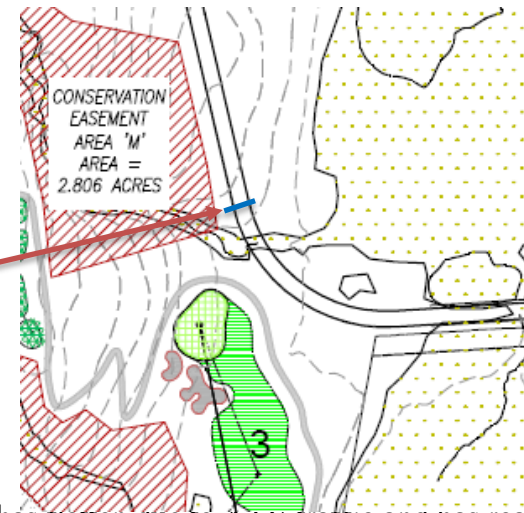
1. Main Entry Water Crossing (Northerly of 3 rd Hole Green)	<input checked="" type="checkbox"/> Yes <input type="checkbox"/> No	<input type="checkbox"/> Yes <input checked="" type="checkbox"/> No		Stone check dam immediately upgradient of crossing has been partially flattened due to trespassing ATVs and has reached full capacity (Photo 1). Stone check dam in trail leading down to crossing has reached capacity (Photo 2). Both check dams need accumulated sediment removed and minor repair. Additional check dams could be added along the trail could be added to address channelized flow in tire ruts.

Photo 1: Stone check dam immediately upgradient of main entry water crossing has flattened due to A1V traffic and has reached capacity with collected sediment.

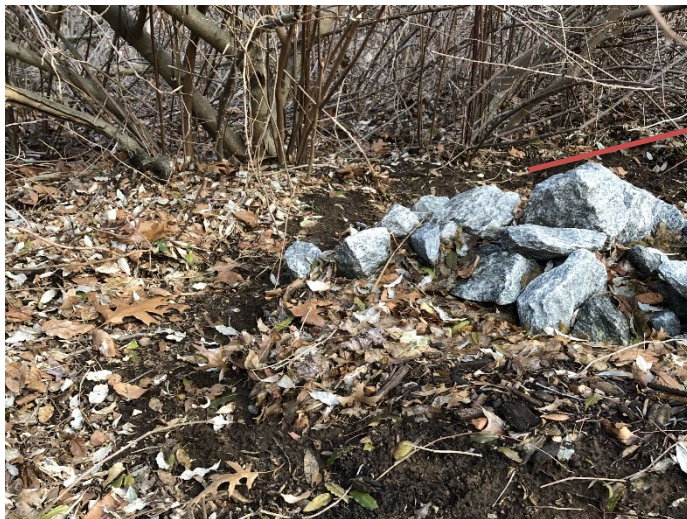
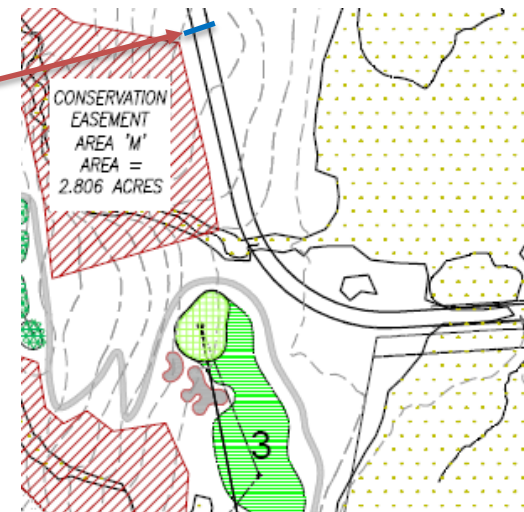
Photo 2: Stone check dam in path leading to water crossing has reached capacity and allowed sediment to flow around check dam.

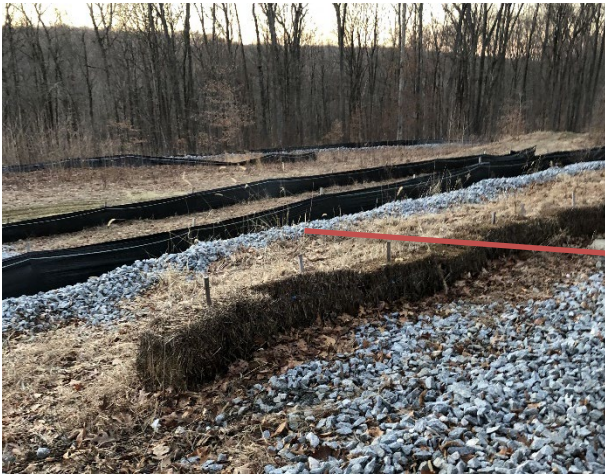
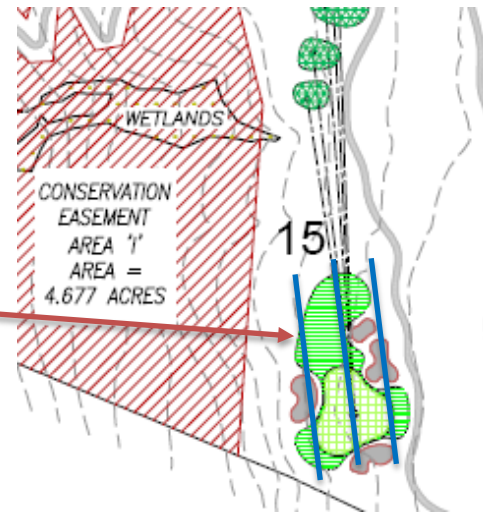
Photo 3: Some sediment fence repairs are needed for undermining at upper and lower sediment fence rows. Intermediate sediment fence through sapling stand is beginning to fail and should be restaked. Sediment should be removed from check dams.

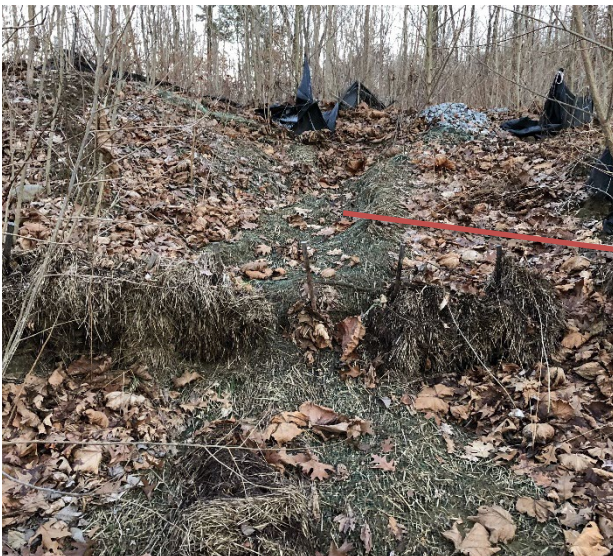
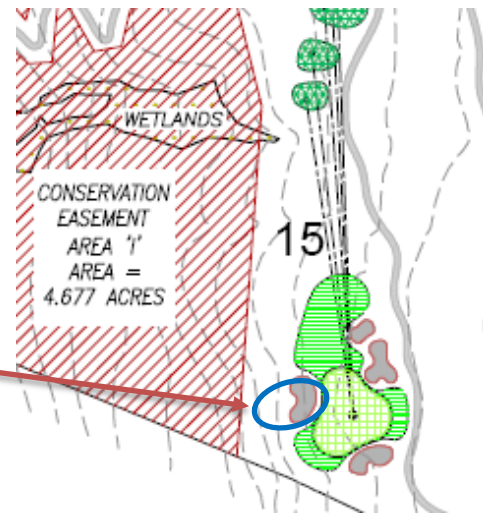
2. 15 th Green Sediment Barriers	<input checked="" type="checkbox"/> Yes <input type="checkbox"/> No	<input type="checkbox"/> Yes <input checked="" type="checkbox"/> No		Downgradient stone check dam remains in good condition. Sediment fence along the cart path and along the tree line have undermined in two locations each and should be repaired. Check dams should have collected sediment removed. Intermediate fence needs to be restaked. (Photo 3). Sediment fence rows and staked hay bales in south end have deteriorated and need to be replaced (Photo 4).

Photo 4: Staked hay bales and sediment fence in area shown have failed/deteriorated. There is erosion under the erosion control mat. Check dams should be added to replace deteriorated erosion control measures.

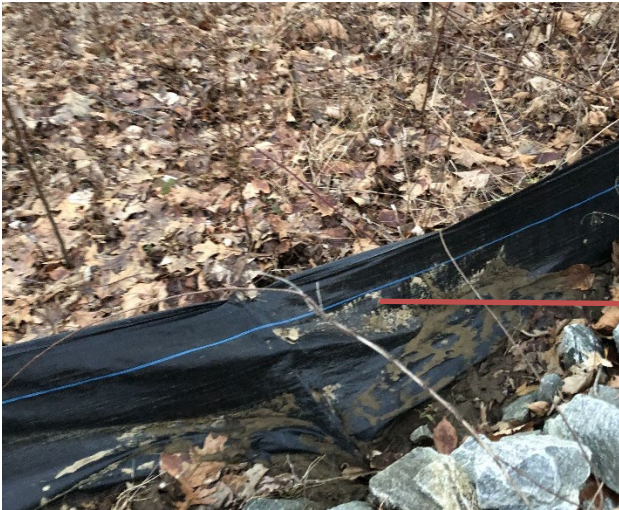
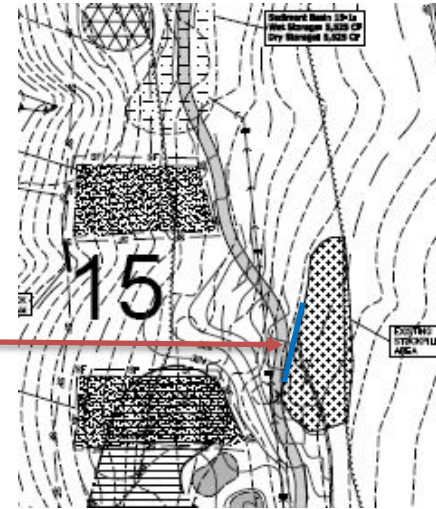
3. 15 th Fairway Sediment Barriers	<input checked="" type="checkbox"/> Yes <input type="checkbox"/> No	<input type="checkbox"/> Yes <input checked="" type="checkbox"/> No		Stone check dams, stone apron are in good condition and functioning as intended. Collected sediment should be removed (Photo 5). Sediment fence has been downed and should be repaired.

Photo 5: Stone check dams and staked hay bales are in good condition. Collected sediment should be removed and sediment fence repaired.

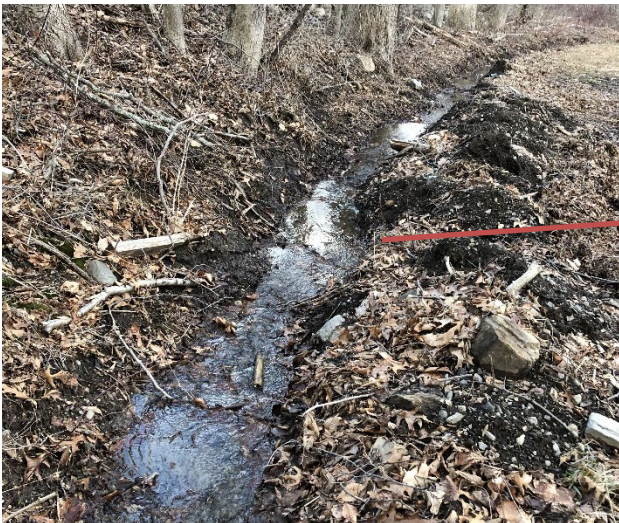
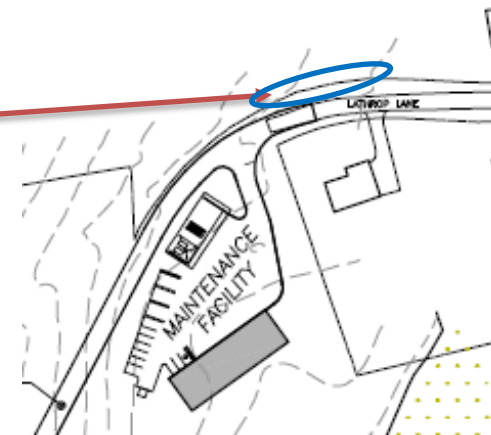
Photo 6: Recently constructed swale carrying flow to downgradient drainage structure. No signs of erosion in swale.

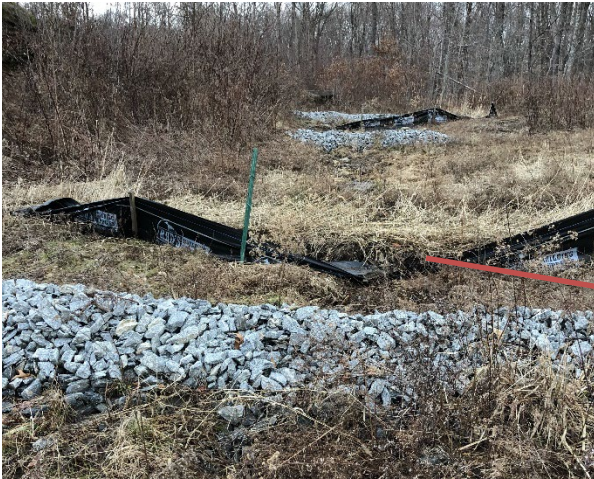
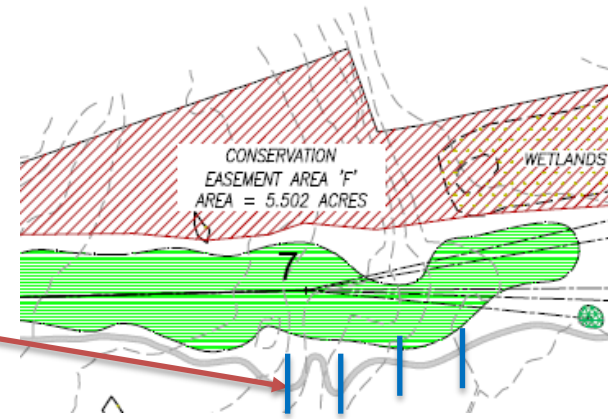
5. 7 th Hole Fairway Hillside	<input checked="" type="checkbox"/> Yes <input type="checkbox"/> No	<input type="checkbox"/> Yes <input checked="" type="checkbox"/> No		Check dams across 7 th Hole fairway are in good condition overall and functioning as intended (Photo 7). Sediment fence has failed in several locations however given the upgradient vegetation failed sediment fence could be replaced with stone check dams instead of repairing.

Photo 7: Stone check dams across the 7th hole fairway hillside remain in good condition. Sediment fence rows and hay bales have deteriorated. Since upgradient areas are vegetated the sediment fence could be replaced with additional stone check dams to prevent erosion from channelized flows..

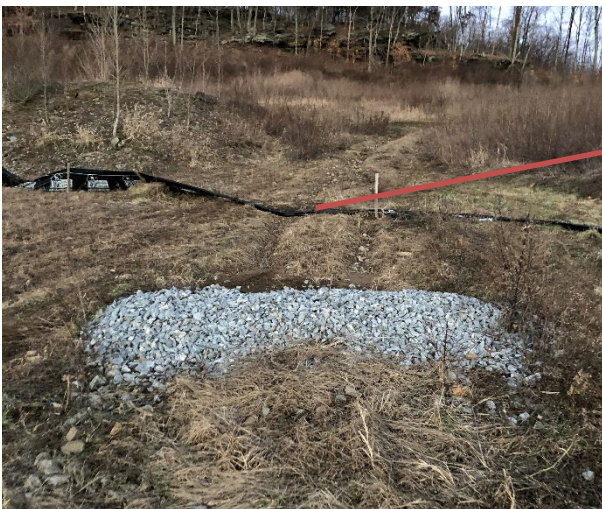
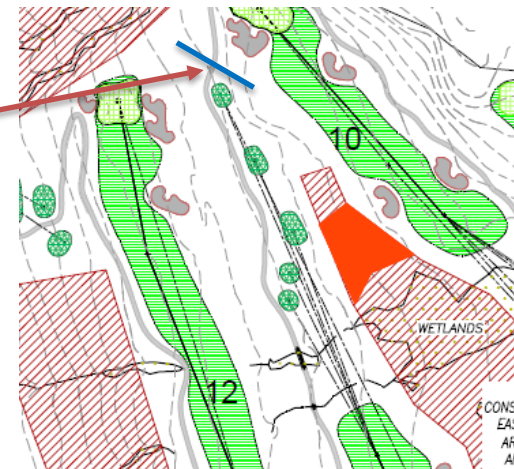
6. 11 th Hole Tee Box Area	<input checked="" type="checkbox"/> Yes <input type="checkbox"/> No	<input type="checkbox"/> Yes <input checked="" type="checkbox"/> No		Sediment fence row across path by 11 th Hole tee box has failed due to ATV traffic (Photo 8). At time of inspection the area was stable except for tracking and rutting due to ATV traffic. Stone check dams could be installed across ATV track to disrupt channelized flow.

Photo 8: Sediment fence row across 11th hole tee box area has been knocked over by ATV traffic.

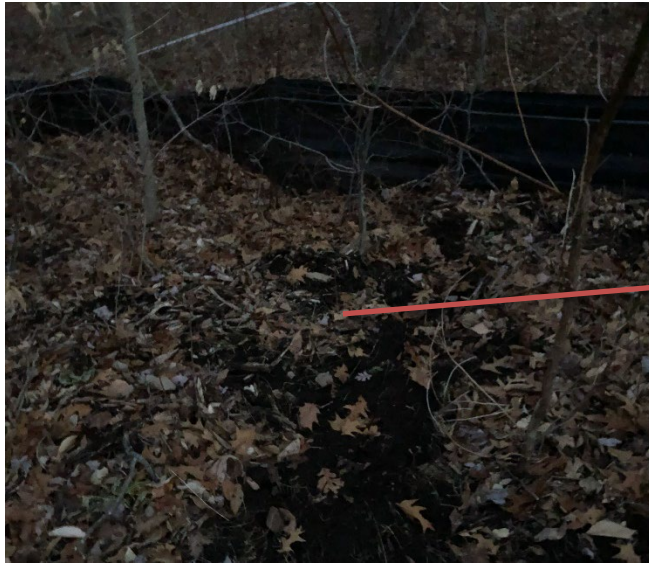
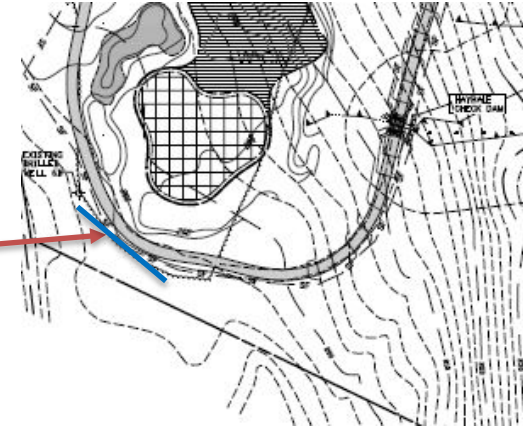
7. 14 th Hole Green Sediment Barriers	<input checked="" type="checkbox"/> Yes <input type="checkbox"/> No	<input type="checkbox"/> Yes <input checked="" type="checkbox"/> No		Sediment fence row at tree line is allowing flow underneath in one location and needs to be corrected (Photo 9). Additional flow paths have begun along the cart path and a stone check dam should be added at the undermined sediment fence.

Photo 9: Sediment fence at tree line by 14th hole is allowing flow underneath in one location and should be repaired. An additional stone check dam could be added upgradient of protected area to disrupt channelized flows.

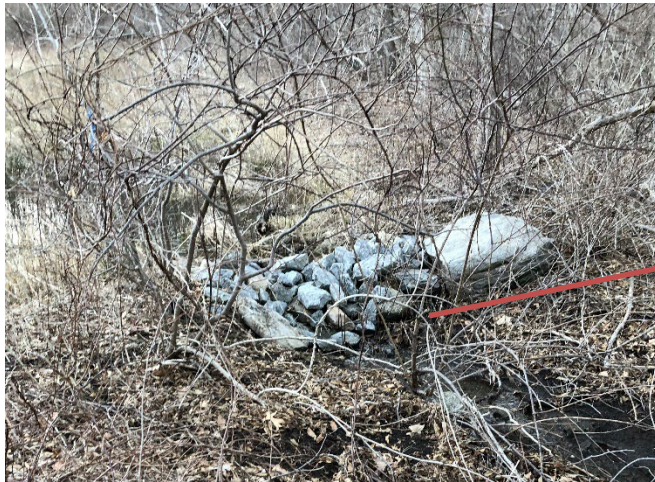
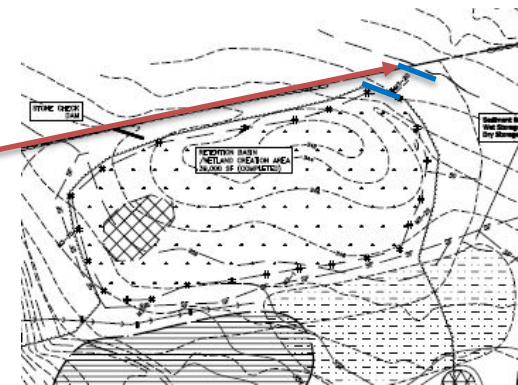
8. Created Wetlands Outlet	<input type="checkbox"/> Yes <input checked="" type="checkbox"/> No	<input type="checkbox"/> Yes <input checked="" type="checkbox"/> No		(Photo 10).

Photo 10: Flow from created wetlands outlet.
