**General Information**  
(see reverse for instructions)

<b>Name of Project</b>	Franklin Hills Estates & Country Club	<b>CGP Tracking No.</b>	IR #20-10	<b>Inspection Date</b>	1/18/2021
<b>Inspector Name, Title &amp; Contact Information</b>	Inspector: David C. McKay, P.E.		Reviewer: David McKay, P.E.		
<b>Present Phase of Construction</b>	Phase 1				
<b>Inspection Location</b> (if multiple inspections are required, specify location where this inspection is being conducted)	Areas of Concern as defined at site walk with wetlands commission				
<p><b>Inspection Frequency</b> (Note: you may be subject to different inspection frequencies in different areas of the site. Check all that apply.)</p> <p><b>Standard Frequency:</b>   <input type="checkbox"/> Weekly      <input type="checkbox"/> within 24 hours of a 0.5" rain</p> <p><b>Increased Frequency:</b>   <input type="checkbox"/> Every 7 days and within 24 hours of a 0.5" rain (for areas of sites discharging to sediment or nutrient-impaired waters or to waters designated as Tier 2, Tier 2.5, or Tier 3)</p> <p><b>Reduced Frequency:</b></p> <ul style="list-style-type: none"> <li>- <input type="checkbox"/> Once per month (for stabilized are

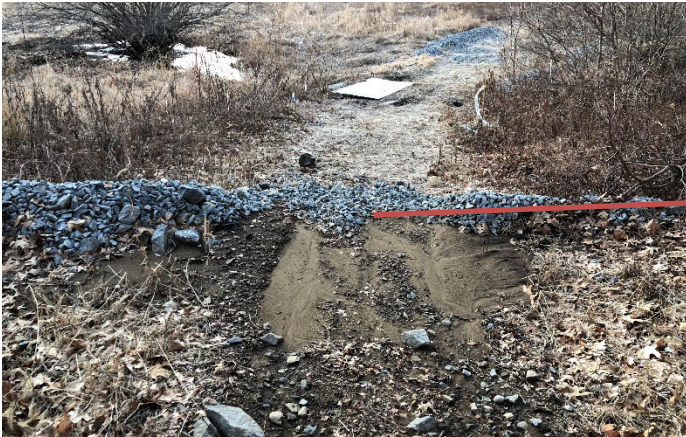
1. Main Entry Water Crossing (Northerly of 3 <sup>rd</sup> Hole Green)	<input checked="" type="checkbox"/> Yes <input type="checkbox"/> No	<input type="checkbox"/> Yes <input checked="" type="checkbox"/> No		Stone check dam immediately upgradient of crossing has been partially flattened due to trespassing ATVs and has reached full capacity (Photo 1). Stone check dam in trail leading down to crossing has reached capacity (Photo 2). Both check dams need accumulated sediment removed and minor repair. Additional check dams could be added along the trail could be added to address channelized flow in tire ruts.

Photo 1: Stone check dam immediately upgradient of main entry water crossing has flattened due to ATV traffic and has reached capacity with collected sediment.

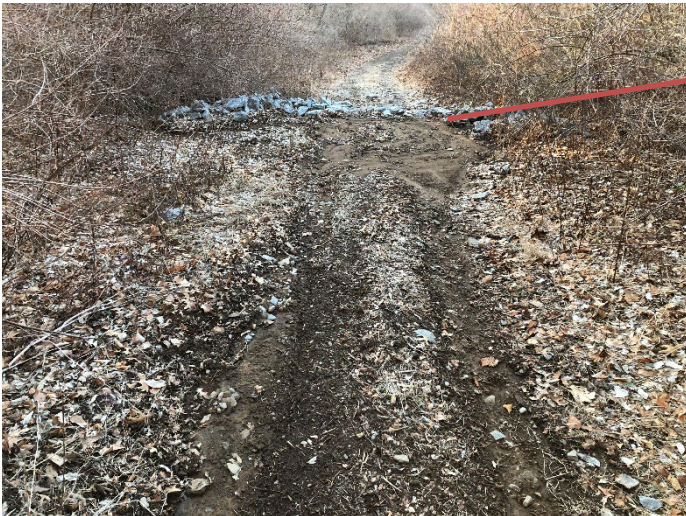
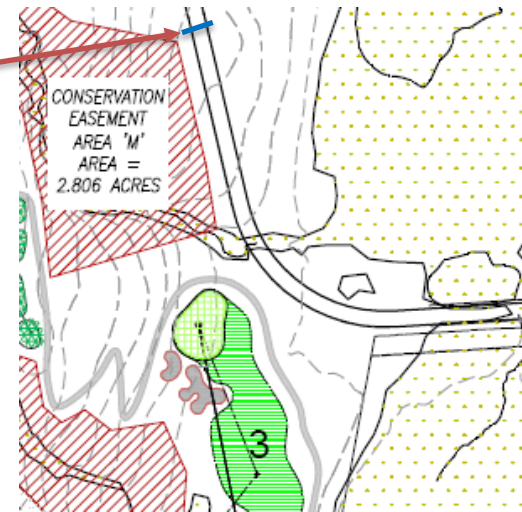
Photo 2: Stone check dam in path leading to water crossing has reached capacity and allowed sediment to flow around check dam.

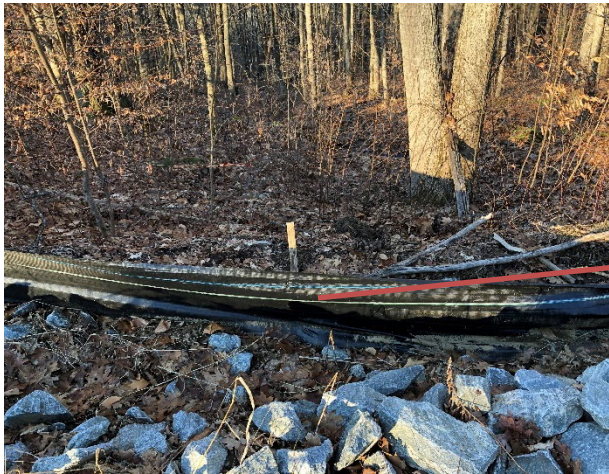
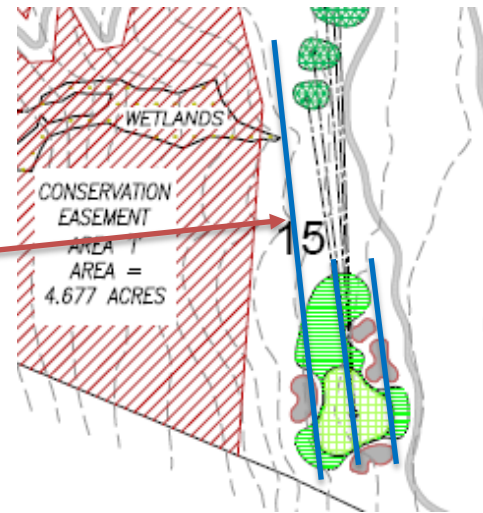
3. 15 <sup>th</sup> Hole Fairway	Plans – Silt fence and stone check dam Existing – Series of stone check dams and silt fence at limits of wooded area to the west	<input checked="" type="checkbox"/> Yes <input type="checkbox"/> No <input type="checkbox"/> N/A	Erosion is occurring at the southern limit of the green where erosion control mats were previously installed. This area should be stabilized with stone since dense vegetation has not been established under the mat. Stone check dams and sediment fence rows remain in generally good condition. Collected sediment from check dams should be removed. Sediment fence is undermined at the cart path and along the and should be repaired or reinforced with stone check dams. Intermediate sediment fence through the sapling stand should be re-staked in failed areas.

Photo 3: Some sediment fence repairs are needed for undermining at upper and lower sediment fence rows. Undermined areas should be reinforced with stone check dams. Intermediate sediment fence through sapling stand is beginning to fail and should be re-staked. Sediment should be removed from check dams.

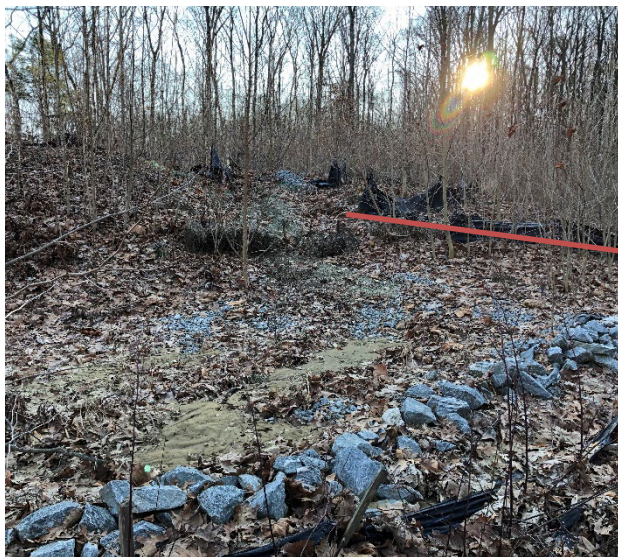
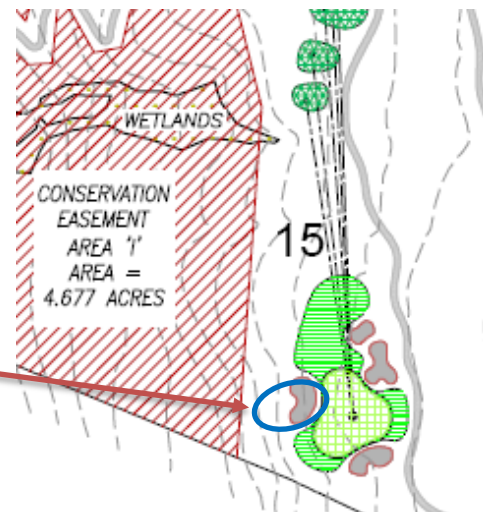
2. 15 <sup>th</sup> Green Sediment Barriers	<input checked="" type="checkbox"/> Yes <input type="checkbox"/> No	<input type="checkbox"/> Yes <input checked="" type="checkbox"/> No		Downgradient stone check dam remains in good condition. Sediment fence along the cart path and along the tree line have undermined in several locations each and should be repaired or reinforced with stone check dams. Southern check dams should have collected sediment removed. Intermediate fence needs to be re-staked. (Photo 3). Sediment fence rows and staked hay bales in south end have deteriorated and need to be replaced (Photo 4).

Photo 4: Staked hay bales and sediment fence in area shown have failed/deteriorated. There is erosion under the erosion control mat. Check dams should be added to replace deteriorated erosion control measures. Collected sediment should be removed.

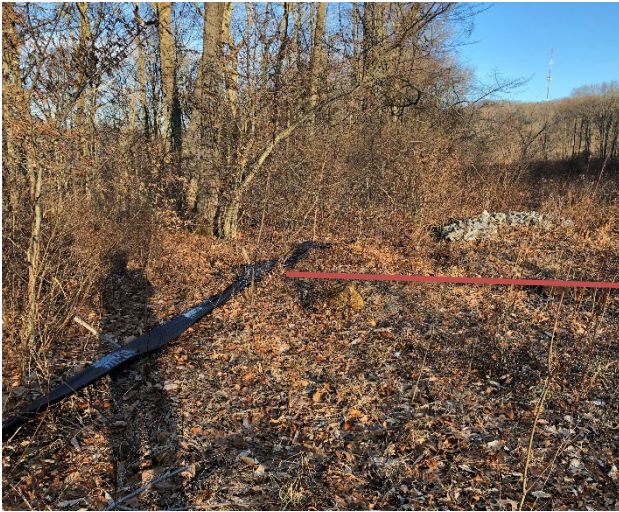
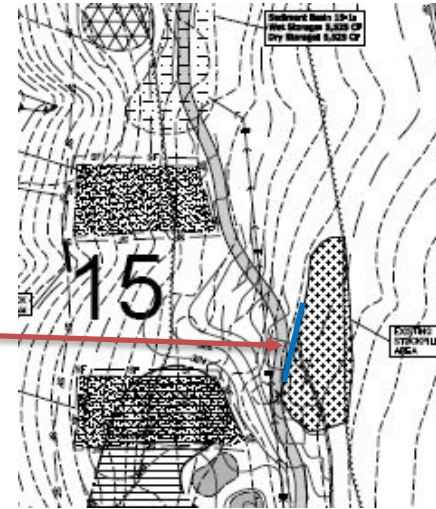
3. 15 <sup>th</sup> Fairway Sediment Barriers	<input checked="" type="checkbox"/> Yes <input type="checkbox"/> No	<input type="checkbox"/> Yes <input checked="" type="checkbox"/> No		Stone check dams, stone apron are in good condition and functioning as intended. Collected sediment should be removed (Photo 5). Sediment fence has been downed and should be repaired.

Photo 5: Stone check dams and staked hay bales are in good condition. Collected sediment should be removed and sediment fence repaired.

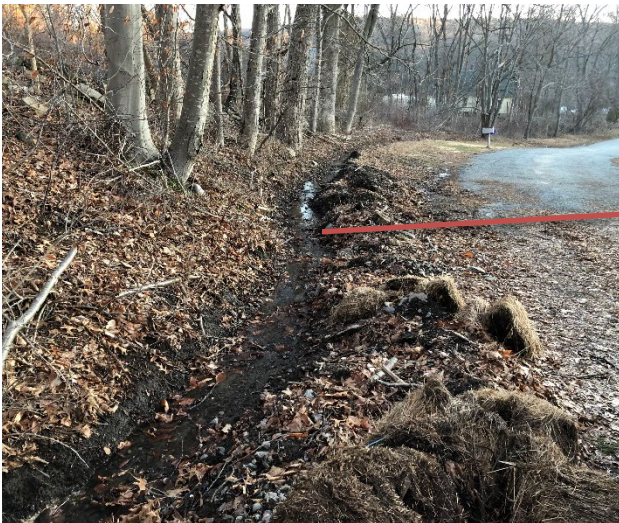
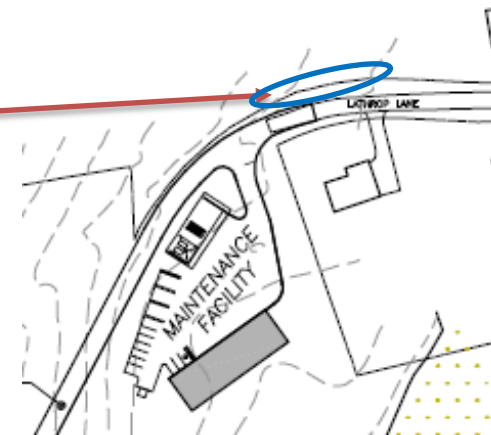
Photo 6: Recently constructed swale carrying flow to downgradient drainage structure. No signs of erosion in swale.

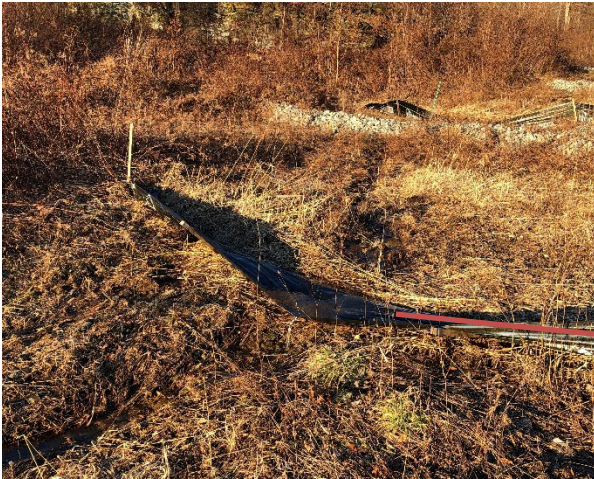
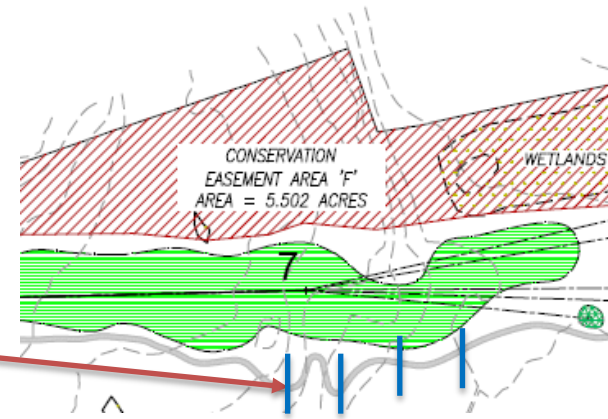
5. 7 <sup>th</sup> Hole Fairway Hillside	<input checked="" type="checkbox"/> Yes <input type="checkbox"/> No	<input type="checkbox"/> Yes <input checked="" type="checkbox"/> No		Check dams across 7 <sup>th</sup> Hole fairway are in good condition overall and functioning as intended (Photo 7). Sediment fence has failed in several locations however given the upgradient vegetation failed sediment fence could be replaced with stone check dams instead of repairing.

Photo 7: Stone check dams across the 7<sup>th</sup> hole fairway hillside remain in good condition. Sediment fence rows and hay bales have deteriorated. Since upgradient areas are vegetated the sediment fence could be replaced with additional stone check dams to prevent erosion from channelized flows.

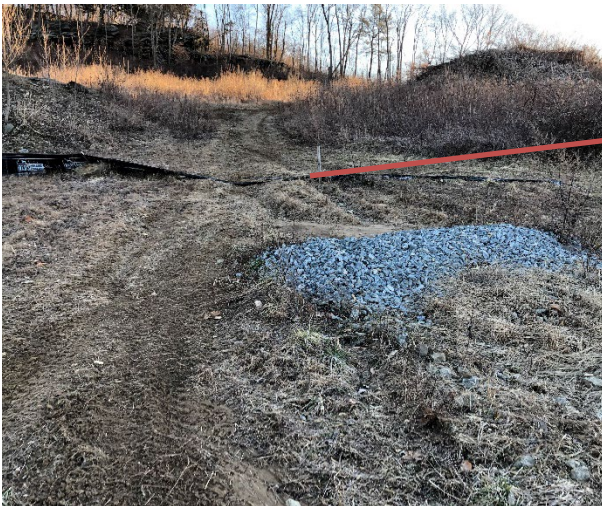
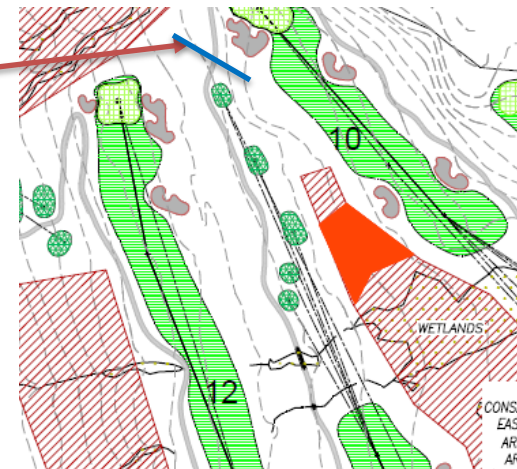
6. 11 <sup>th</sup> Hole Tee Box Area	<input checked="" type="checkbox"/> Yes <input type="checkbox"/> No	<input type="checkbox"/> Yes <input checked="" type="checkbox"/> No		Sediment fence row across path by 11 <sup>th</sup> Hole tee box has failed due to ATV traffic (Photo 8). At time of inspection the area was stable except for tracking and rutting due to ATV traffic. Stone check dams could be installed across ATV track to disrupt channelized flow. Existing stone check dam needs removal of collected sediment.

Photo 8: Sediment fence row across 11<sup>th</sup> hole tee box area has been knocked over by ATV traffic. Remove collected sediment from check dam.

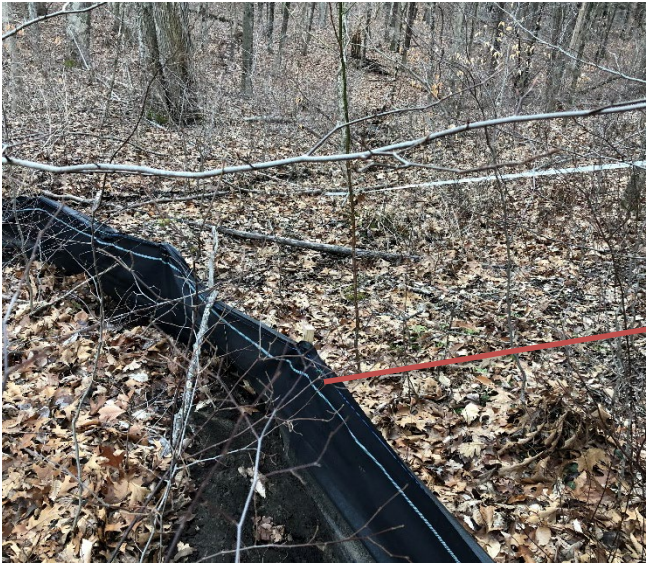
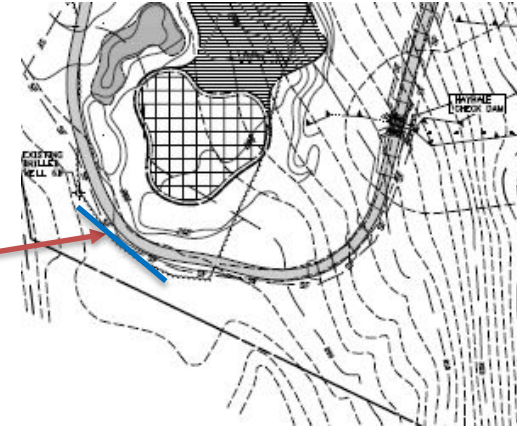
7. 14 <sup>th</sup> Hole Green Sediment Barriers	<input checked="" type="checkbox"/> Yes <input type="checkbox"/> No	<input type="checkbox"/> Yes <input checked="" type="checkbox"/> No		Sediment fence row at tree line is allowing flow underneath in two locations and needs to be corrected (Photo 9). Additional flow paths have begun along the cart path and a stone check dam should be added at the undermined sediment fence.

Photo 9: Sediment fence at tree line by 14<sup>th</sup> hole is allowing flow underneath in two location and should be repaired and reinforced with a stone check dam. An additional stone check dam could be added upgradient of protected area to disrupt channelized flows.

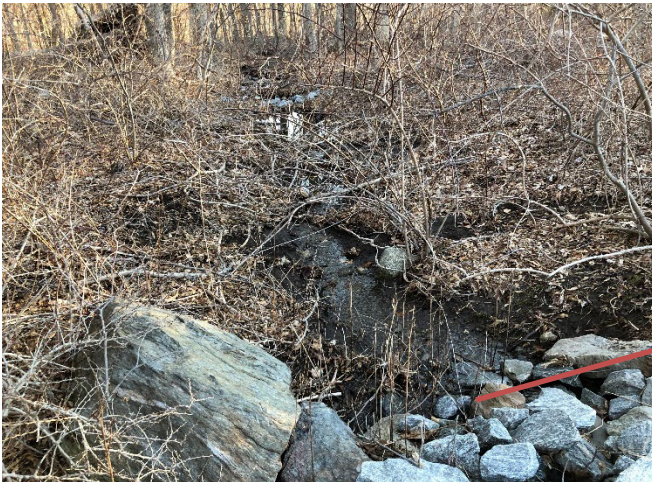
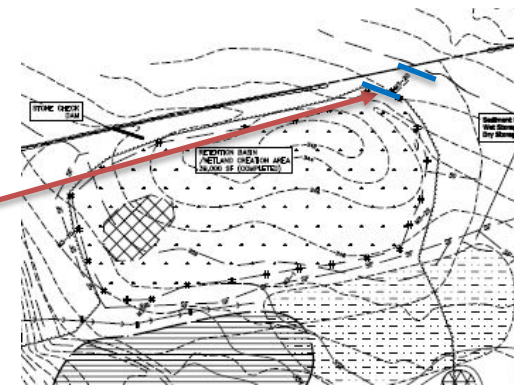
8. Created Wetlands Outlet	<input type="checkbox"/> Yes <input checked="" type="checkbox"/> No	<input type="checkbox"/> Yes <input checked="" type="checkbox"/> No		(Photo 10).

Photo 10: Flow from created wetlands outlet.
