**General Information**  
(see reverse for instructions)

<b>Name of Project</b>	Franklin Hills Estates & Country Club	<b>CGP Tracking No.</b>	IR #21-7	<b>Inspection Date</b>	3/29/2021
<b>Inspector Name, Title &amp; Contact Information</b>	Inspector: David McKay, P.E.		Reviewer: David McKay, P.E.		
<b>Present Phase of Construction</b>	Phase 1				
<b>Inspection Location</b> (if multiple inspections are required, specify location where this inspection is being conducted)	Areas of Concern as defined at site walk with wetlands commission.				
<p><b>Inspection Frequency</b> (Note: you may be subject to different inspection frequencies in different areas of the site. Check all that apply.)</p> <p><b>Standard Frequency:</b>   <input type="checkbox"/> Weekly      <input type="checkbox"/> within 24 hours of a 0.5" rain</p> <p><b>Increased Frequency:</b>   <input type="checkbox"/> Every 7 days and within 24 hours of a 0.5" rain (for areas of sites discharging to sediment or nutrient-impaired waters or to waters designated as Tier 2, Tier 2.5, or Tier 3)</p> <p><b>Reduced Frequency:</b></p> <ul style="list-style-type: none"> <li>- <input type="checkbox"/> Once per month (for stabilized areas)

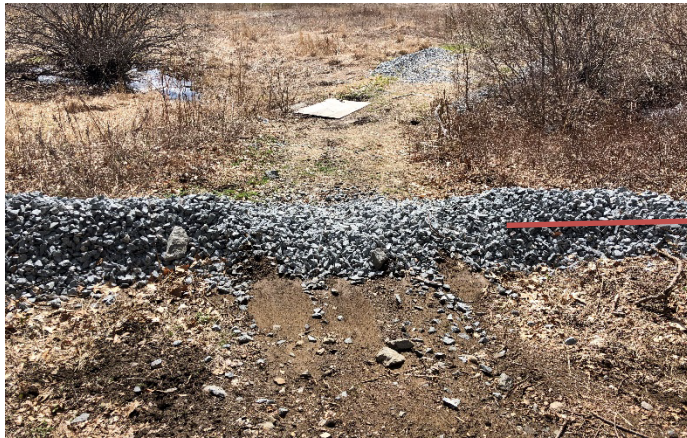
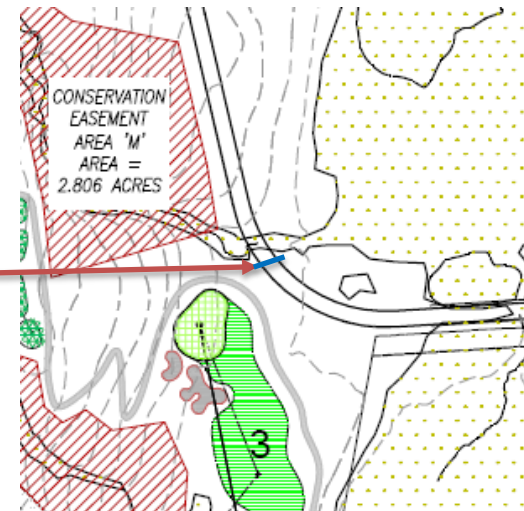
1. Main Entry Water Crossing (Northerly of 3 <sup>rd</sup> Hole Green)	<input type="checkbox"/> Yes <input checked="" type="checkbox"/> No	<input type="checkbox"/> Yes <input checked="" type="checkbox"/> No		Stone check dam immediately upgradient of crossing has ample storage capacity (Photo 1). Stone check dam in trail leading down to crossing has ample storage capacity (Photo 2). Some off-road vehicles have started to damage the check dams, but ample capacity is still available.

Photo 1: Stone check dam immediately upgradient of main entry water crossing is in good condition. Some off-road vehicles have started to damage the check dams, but ample capacity is still available.

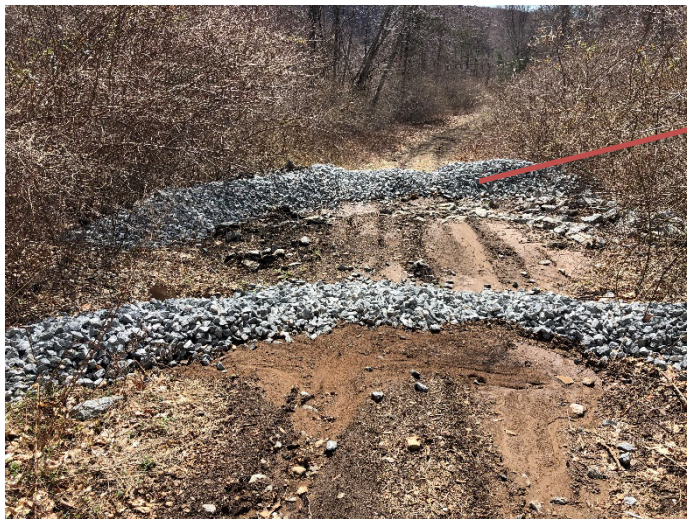
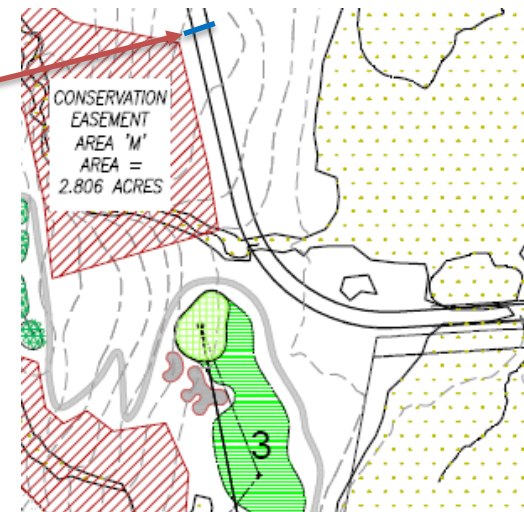
Photo 2: Stone check dams in path leading to water crossing are in good condition. Some off-road vehicles have started to damage the check dams, but ample capacity is still available.

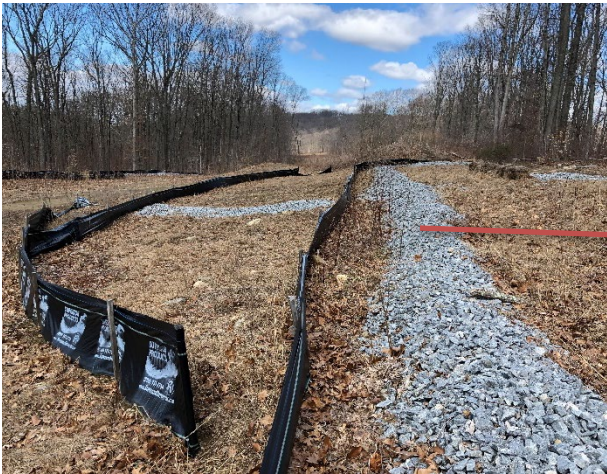
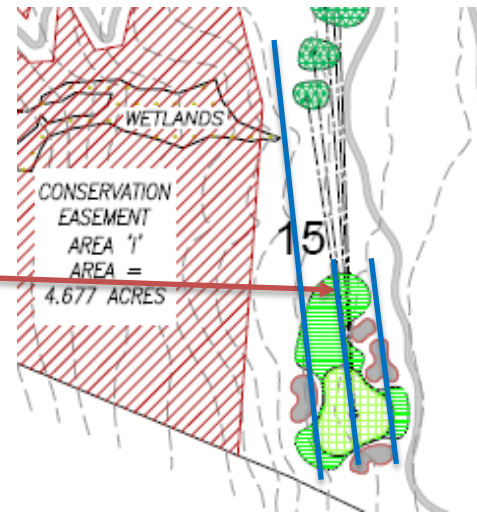
2. 15 <sup>th</sup> Green Sediment Barriers	<input type="checkbox"/> Yes <input checked="" type="checkbox"/> No	<input type="checkbox"/> Yes <input checked="" type="checkbox"/> No		Downgradient stone check dam remains in good condition. Sediment fence along the cart path and along the tree line are in good condition. Intermediate sediment fence has been re-staked. (Photo 3). Sediment fence rows and staked hay bales in south end have been repaired and eroded area has been stabilized with stone. (Photo 4).

Photo 3: Sediment fence has been repaired and reinforced with stone check dams and is in good condition.

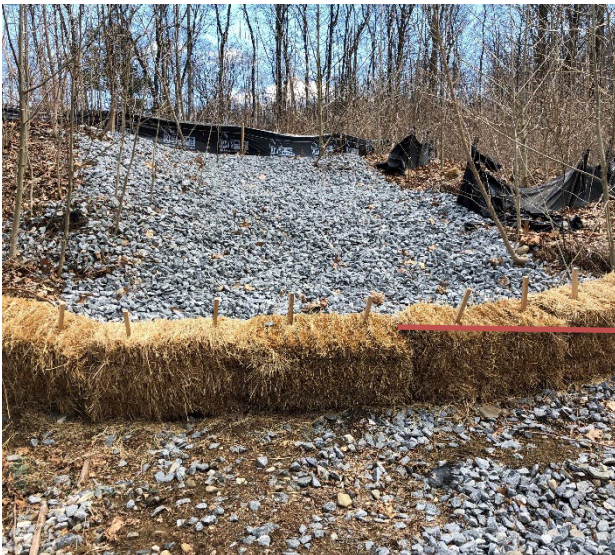
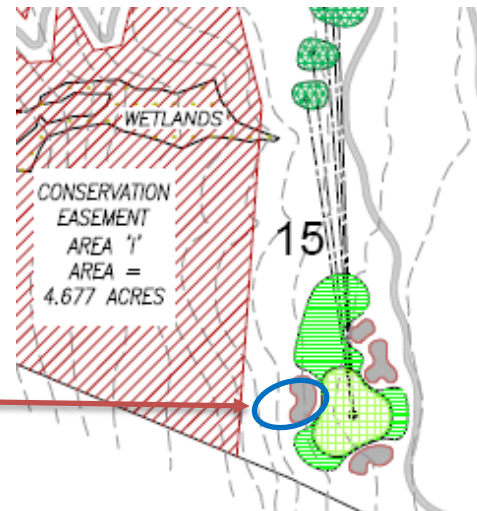
Photo 4: Staked hay bales have been replaced and eroded area has been stabilized with stone and is in good condition.

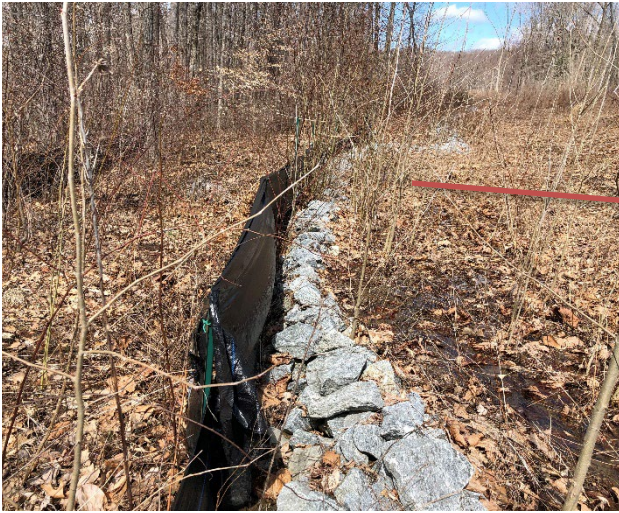
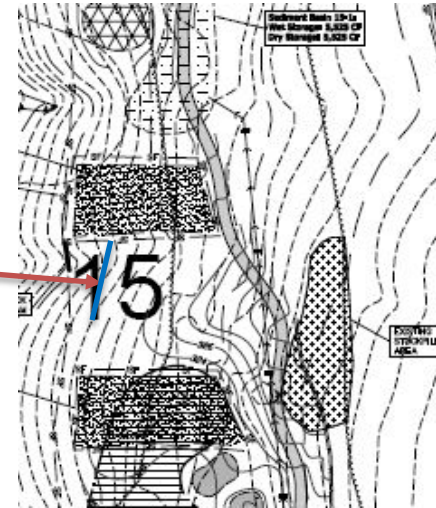
3. 15 <sup>th</sup> Fairway Sediment Barriers	<input type="checkbox"/> Yes <input checked="" type="checkbox"/> No	<input type="checkbox"/> Yes <input checked="" type="checkbox"/> No		Stone check dams, stone apron are in good condition and functioning as intended. (Photo 5).

3. 15 <sup>th</sup> Hole Fairway	Plans – Silt fence and stone check dam Existing – Series of stone check dams and silt fence at limits of wooded area to the west	<input checked="" type="checkbox"/> Yes <input type="checkbox"/> No <input type="checkbox"/> N/A	Stone check dams and apron are in good condition and functioning as intended. Clear flow was observed passing through the check dams.

Photo 5: Filtered flow along 15<sup>th</sup> fairway at stone check dams and perimeter sediment fence.

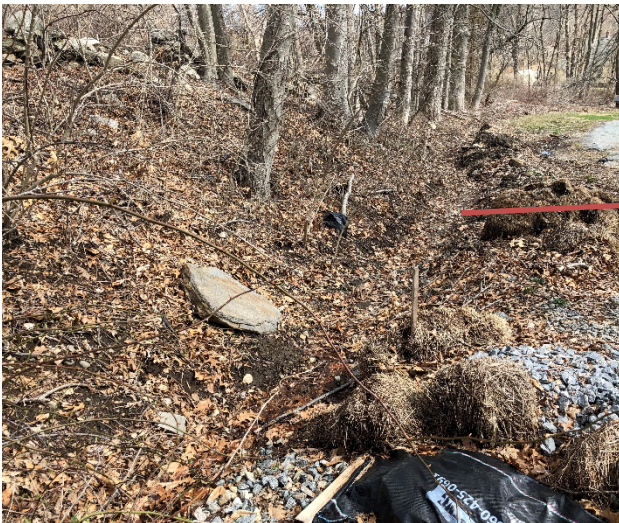
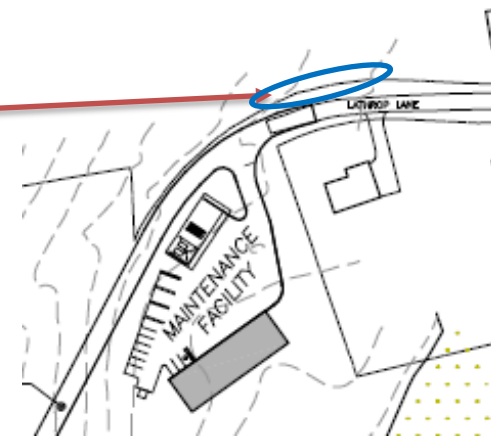
4. Construction Entrance (Westerly of Proposed Maintenance Road)	<input type="checkbox"/> Yes <input checked="" type="checkbox"/> No	<input type="checkbox"/> Yes <input checked="" type="checkbox"/> No		Stone check dam and water bar across construction entrance are in good condition and functioning as intended (Photo 6). Diversion swale excavated to downgradient drainage structure does not show signs of erosion. Stone check dams should be added to new swale if erosion occurs.

Stabilization Area	Stabilization Method	Have You Initiated Stabilization?	Notes
1. Construction Access Drive	Plans - Anti-tracking pad Existing - Water bar at site entrance	<input checked="" type="checkbox"/> Yes <input type="checkbox"/> No <input type="checkbox"/> N/A	There was no flow in the swale during the inspection with no evidence of erosion. Add stone check dams to swale if erosion occurs.

Photo 6: No signs of erosion in swale at entrance driveway.

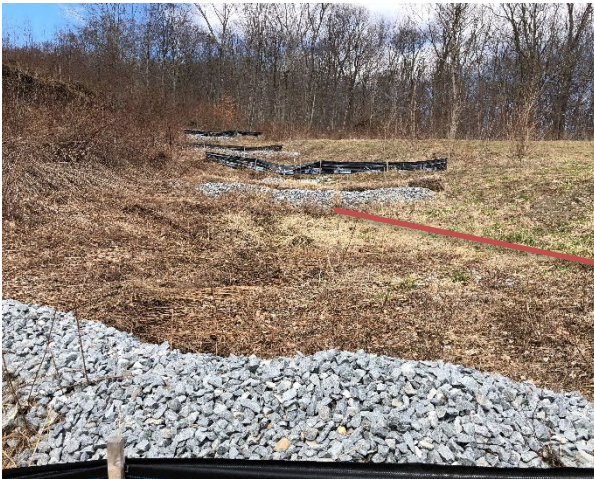
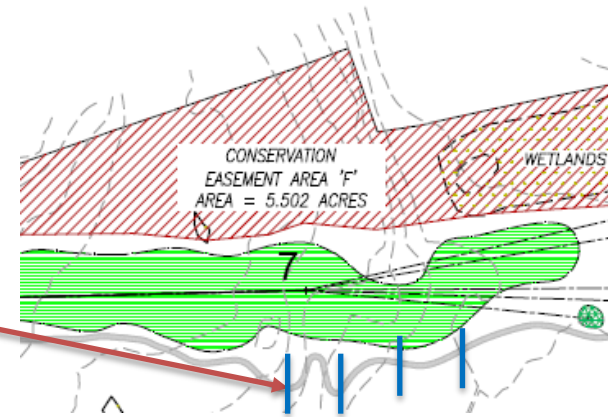
5. 7 <sup>th</sup> Hole Fairway Hillside	<input type="checkbox"/> Yes <input checked="" type="checkbox"/> No	<input type="checkbox"/> Yes <input checked="" type="checkbox"/> No		Check dams across 7 <sup>th</sup> Hole fairway are in good condition overall and functioning as intended (Photo 7). Clear flow was observed passing through the check dams.

2. 7 <sup>th</sup> Hole Fairway Hillside	Plans – Multiple rows of silt fence Existing – Series of stone check dams and silt fence	<input checked="" type="checkbox"/> Yes <input type="checkbox"/> No <input type="checkbox"/> N/A	Area is stabilized at this time. Stone check dams are in good condition and are functioning as intended. Clear flow was observed passing through the check dams.

Photo 7: Stone check dams and sediment fence across the 7<sup>th</sup> hole fairway hillside are in good condition, filtered flow observed.

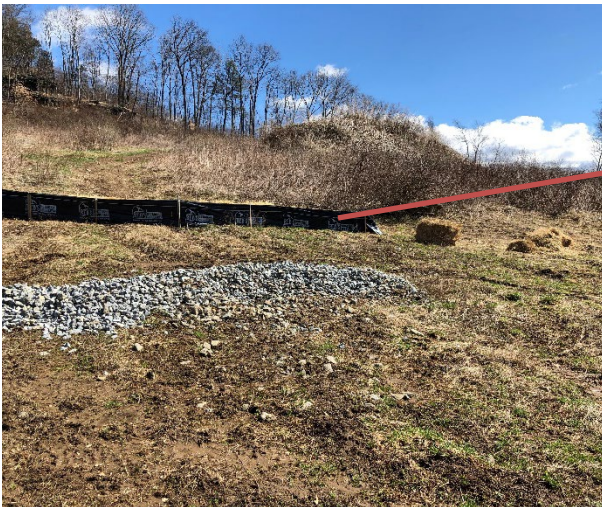
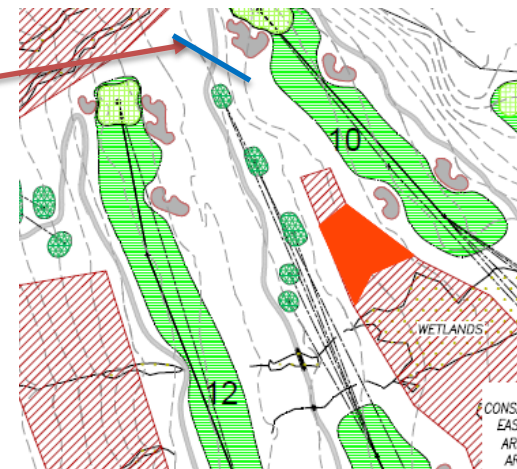
6. 11 <sup>th</sup> Hole Tee Box Area	<input type="checkbox"/> Yes <input checked="" type="checkbox"/> No	<input type="checkbox"/> Yes <input checked="" type="checkbox"/> No		Sediment fence row across path by 11 <sup>th</sup> Hole tee box and hay bale check dam are in good condition (Photo 8). Stone check dam has ample storage capacity. Some off-road vehicles have started to damage the hay bales, but ample capacity is still available.

4. 11 <sup>th</sup> Hole Tee Box Area	Plans – Silt fence and diversion channel Existing – Single row of silt fence across path and one stone check dam	<input checked="" type="checkbox"/> Yes <input type="checkbox"/> No <input type="checkbox"/> N/A	Sediment fence, hay bale check dam and stone check dam are in good condition. Some off-road vehicles have started to damage the hay bales, but ample capacity is still available.

Photo 8: Sediment fence row across 11<sup>th</sup> hole tee box area has been repaired and stone check dam upgraded. A hay bale check dam has been added upgradient of the sediment fence. All measures are in good condition, some off-road vehicle traffic has damaged a portion of the hay bale check dam but adequate storage capacity is still available.

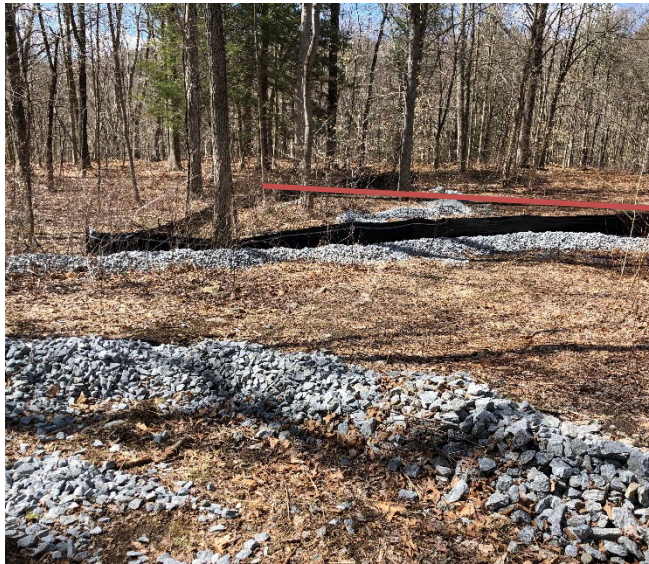
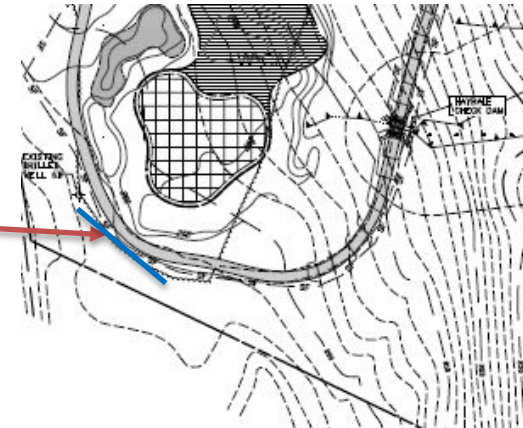
7. 14 <sup>th</sup> Hole Green Sediment Barriers	<input type="checkbox"/> Yes <input checked="" type="checkbox"/> No	<input type="checkbox"/> Yes <input checked="" type="checkbox"/> No		Additional stone check dams and sediment fence are in good condition (Photo 9).

Photo 9: Sediment fence has been repaired and additional stone check dams added to disrupt flows. Measures are in good condition and flow is filtered by stone check dams.

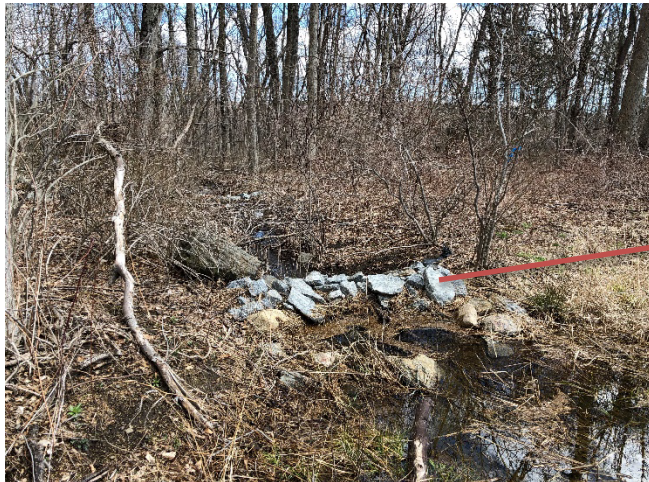
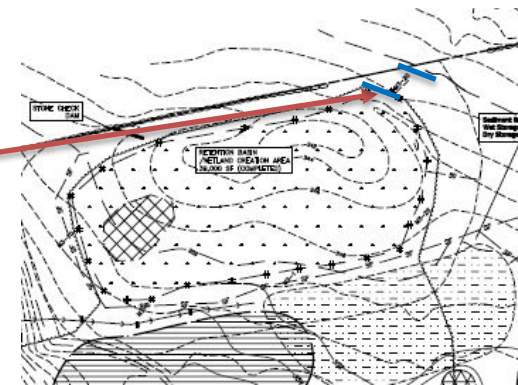
8. Created Wetlands Outlet	<input type="checkbox"/> Yes <input checked="" type="checkbox"/> No	<input type="checkbox"/> Yes <input checked="" type="checkbox"/> No		No repairs required. Discharge from wetlands was flowing clear (Photo 10).

Photo 10: Clear flow from wetlands outlet.
