Name of Project	Franklin Hills Estates & Country Club	CGP Tracking No.	IR #21-8	Inspection Date	4/16/2021
Inspector Name, Title & Contact Information	Inspector: David McKay, P.E.		Reviewer: David McKay, P.E.		
Present Phase of Construction	Phase 1				
Inspection Location (if multiple inspections are required, specify location where this inspection is being conducted)	Areas of Concern as defined at site walk with wetlands commission.				
<p>Inspection Frequency (Note: you may be subject to different inspection frequencies in different areas of the site. Check all that apply.)</p> <p>Standard Frequency: <input type="checkbox"/> Weekly <input type="checkbox"/> within 24 hours of a 0.5" rain</p> <p>Increased Frequency: <input type="checkbox"/> Every 7 days and within 24 hours of a 0.5" rain (for areas of sites discharging to sediment or nutrient-impaired waters or to waters designated as Tier 2, Tier 2.5, or Tier 3)</p> <p>Reduced Frequency:</p> <ul style="list-style-type: none"> - <input type="checkbox"/> Once per month (for stabilized areas) - <input checked="" type="checkbox"/> Once per month and within 24 hours of a 0.5" rain (for arid, semi-arid, or drought-stricken areas during s

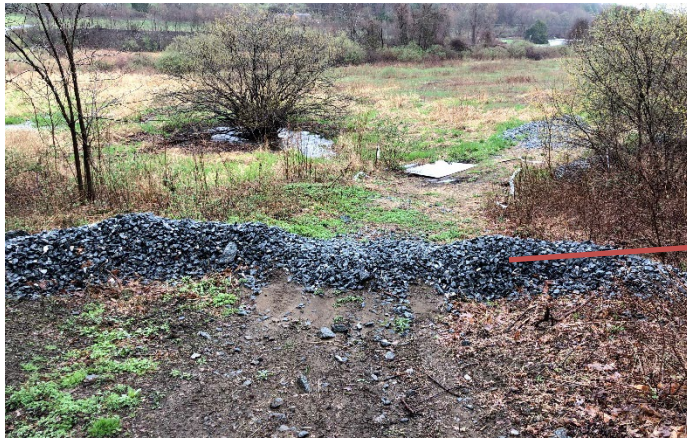
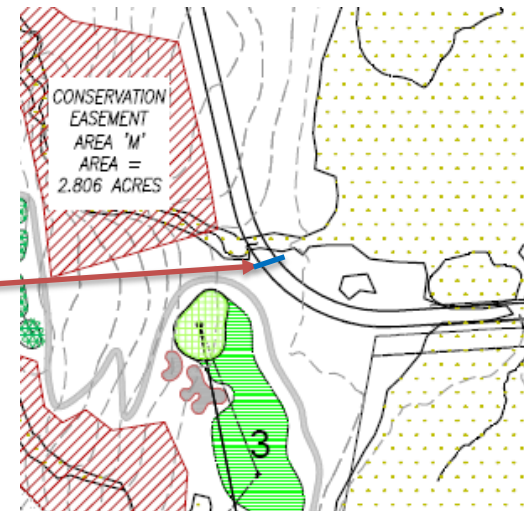
1. Main Entry Water Crossing (Northerly of 3 rd Hole Green)	<input type="checkbox"/> Yes <input checked="" type="checkbox"/> No	<input type="checkbox"/> Yes <input checked="" type="checkbox"/> No		Stone check dam immediately upgradient of crossing has ample storage capacity (Photo 1). Stone check dam in trail leading down to crossing has ample storage capacity (Photo 2). Some off-road vehicles have started to damage the check dams, but ample capacity is still available.

Photo 1: Stone check dam immediately upgradient of main entry water crossing is in good condition. Some off-road vehicles have started to damage the check dams, but ample capacity is still available.

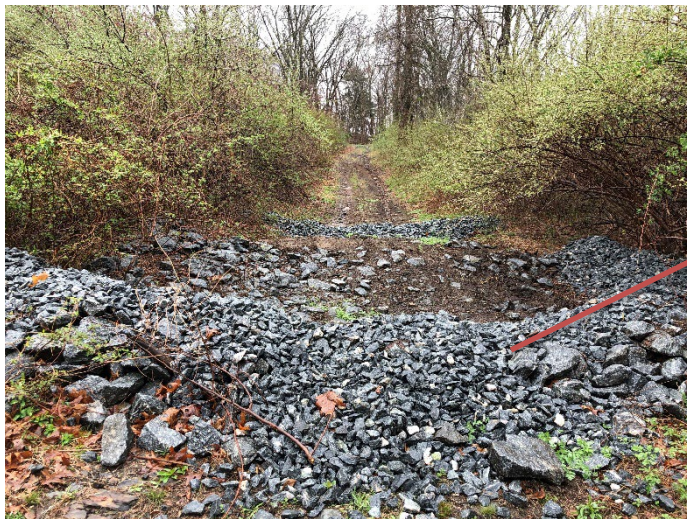
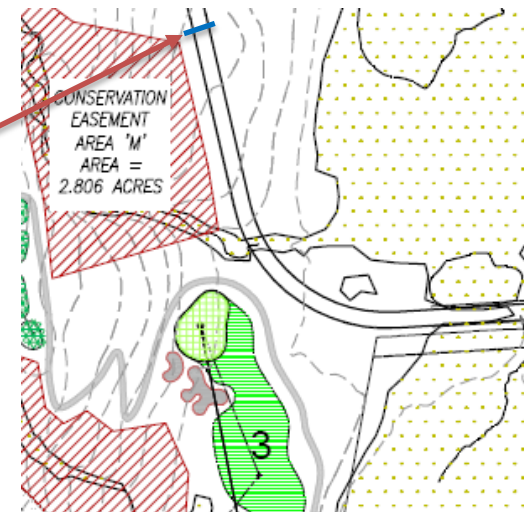
Photo 2: Stone check dams in path leading to water crossing are in good condition. Some off-road vehicles have started to damage the check dams, but ample capacity is still available.

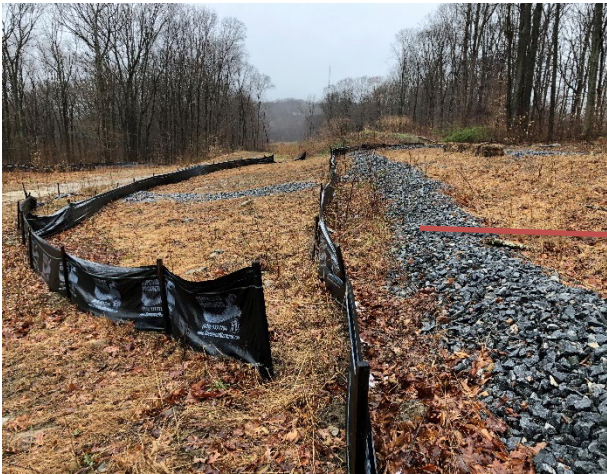
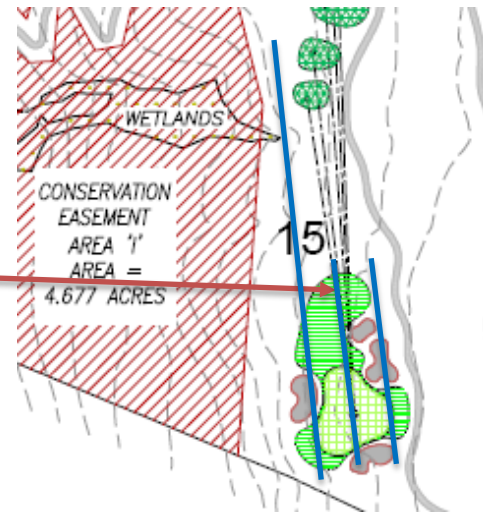
2. 15 th Green Sediment Barriers	<input type="checkbox"/> Yes <input checked="" type="checkbox"/> No	<input type="checkbox"/> Yes <input checked="" type="checkbox"/> No		Downgradient stone check dam remains in good condition. Sediment fence along the cart path and along the tree line are in good condition. Intermediate sediment fence has been re-staked. (Photo 3). Sediment fence rows and staked hay bales in south end have been repaired and eroded area has been stabilized with stone. (Photo 4).

Photo 3: Sediment fence has been repaired and reinforced with stone check dams and is in good condition.

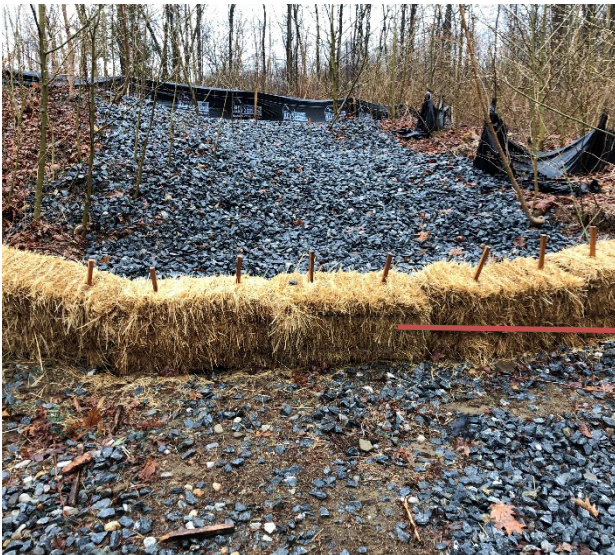
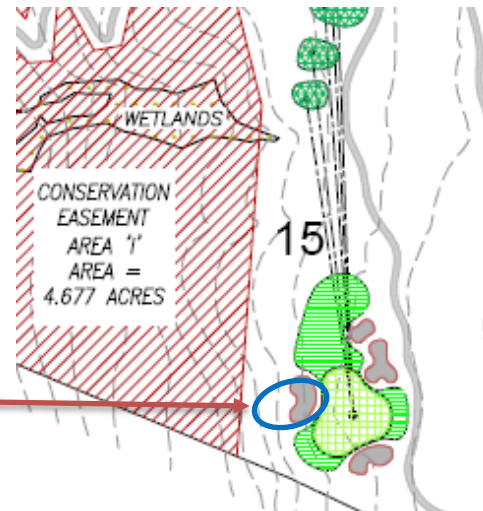
Photo 4: Staked hay bales have been replaced and eroded area has been stabilized with stone and is in good condition.

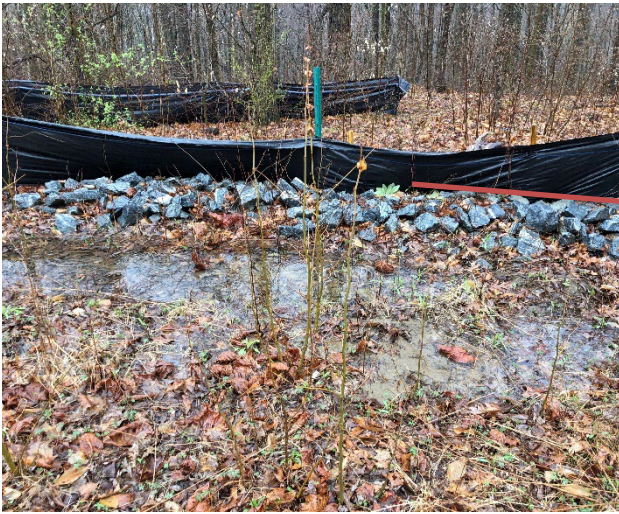
3. 15 th Fairway Sediment Barriers	<input type="checkbox"/> Yes <input checked="" type="checkbox"/> No	<input type="checkbox"/> Yes <input checked="" type="checkbox"/> No		Stone check dams, stone apron are in good condition and functioning as intended. (Photo 5).

3. 15 th Hole Fairway	Plans – Silt fence and stone check dam Existing – Series of stone check dams and silt fence at limits of wooded area to the west	<input checked="" type="checkbox"/> Yes <input type="checkbox"/> No <input type="checkbox"/> N/A	Stone check dams and apron are in good condition and functioning as intended. Clear flow was observed passing through the check dams.

Photo 5: Filtered flow along 15th fairway at stone check dams and perimeter sediment fence.

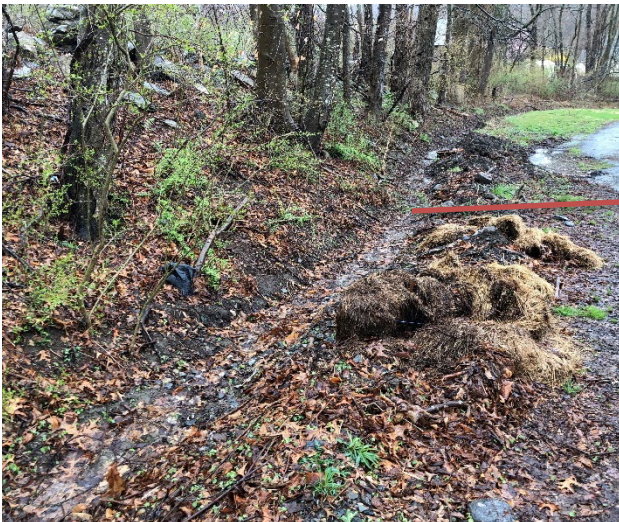
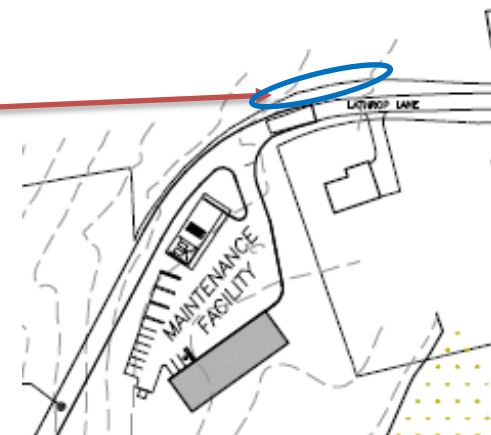
4. Construction Entrance (Westerly of Proposed Maintenance Road)	<input type="checkbox"/> Yes <input checked="" type="checkbox"/> No	<input type="checkbox"/> Yes <input checked="" type="checkbox"/> No		Stone check dam and water bar across construction entrance are in good condition and functioning as intended (Photo 6). Diversion swale excavated to downgradient drainage structure does not show signs of erosion. Stone check dams should be added to new swale if erosion occurs.

Stabilization Area	Stabilization Method	Have You Initiated Stabilization?	Notes
1. Construction Access Drive	Plans - Anti-tracking pad Existing - Water bar at site entrance	<input checked="" type="checkbox"/> Yes <input type="checkbox"/> No <input type="checkbox"/> N/A	There was standing water in the swale during the inspection with no evidence of erosion. Add stone check dams to swale if erosion occurs.

Photo 6: No signs of erosion in swale at entrance driveway.

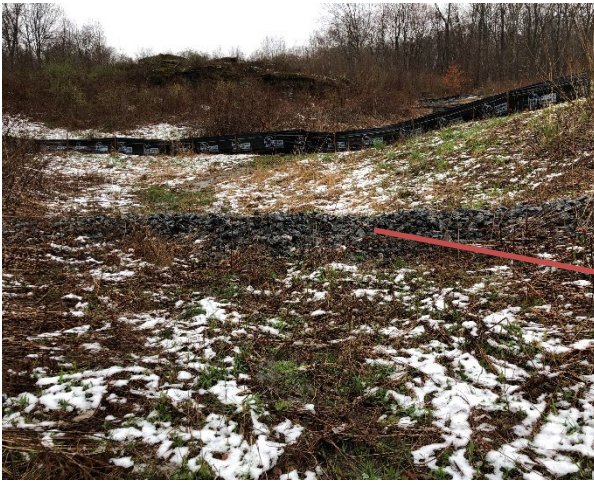
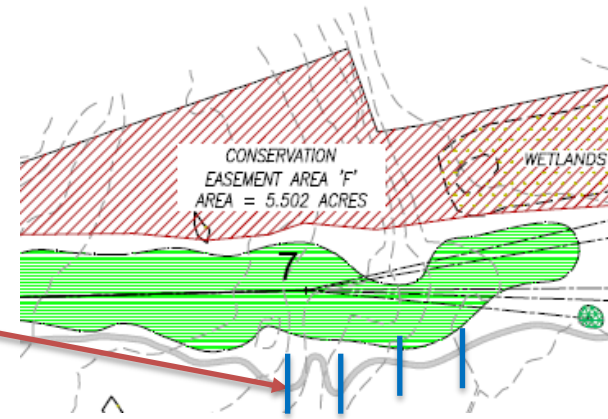
5. 7 th Hole Fairway Hillside	<input type="checkbox"/> Yes <input checked="" type="checkbox"/> No	<input type="checkbox"/> Yes <input checked="" type="checkbox"/> No		Check dams across 7 th Hole fairway are in good condition overall and functioning as intended (Photo 7). Clear flow was observed passing through the check dams.

2. 7 th Hole Fairway Hillside	Plans – Multiple rows of silt fence Existing – Series of stone check dams and silt fence	<input checked="" type="checkbox"/> Yes <input type="checkbox"/> No <input type="checkbox"/> N/A	Area is stabilized at this time. Stone check dams are in good condition and are functioning as intended. Clear flow was observed passing through the check dams.

Photo 7: Stone check dams across the 7th hole fairway hillside are in good condition, filtered flow observed.

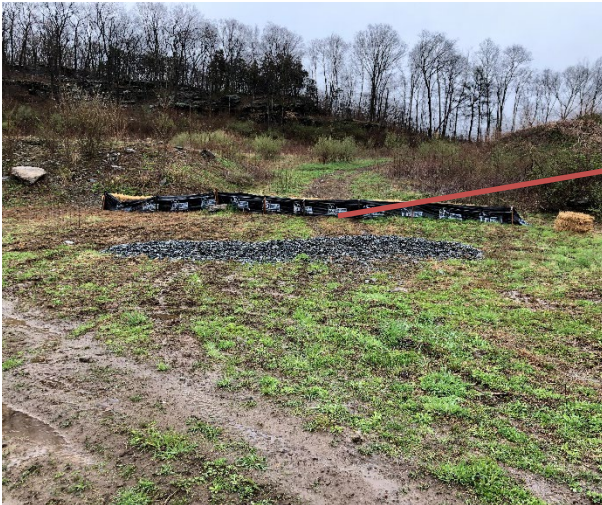
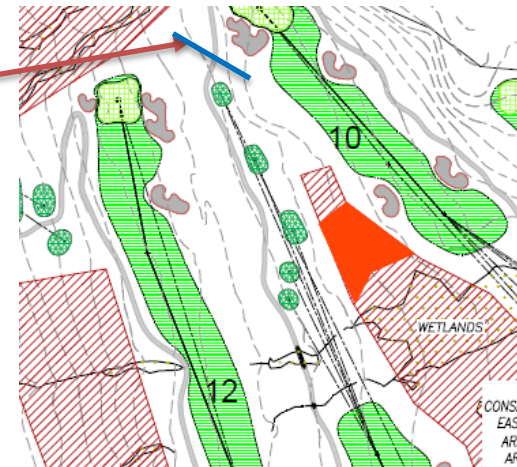
6. 11 th Hole Tee Box Area	<input type="checkbox"/> Yes <input checked="" type="checkbox"/> No	<input type="checkbox"/> Yes <input checked="" type="checkbox"/> No		Sediment fence row across path by 11 th Hole tee box and hay bale check dam are in good condition (Photo 8). Stone check dam has ample storage capacity. Some off-road vehicles have started to damage the hay bales, but ample capacity is still available.

4. 11 th Hole Tee Box Area	Plans – Silt fence and diversion channel Existing – Single row of silt fence across path and one stone check dam	<input checked="" type="checkbox"/> Yes <input type="checkbox"/> No <input type="checkbox"/> N/A	Sediment fence, hay bale check dam and stone check dam are in good condition. Some off-road vehicles have started to damage the hay bales, but ample capacity is still available.

Photo 8: Sediment fence row across 11th hole tee box area has been repaired and stone check dam upgraded. A hay bale check dam has been added upgradient of the sediment fence. All measures are in good condition, some off-road vehicle traffic has damaged a portion of the hay bale check dam but adequate storage capacity is still available.

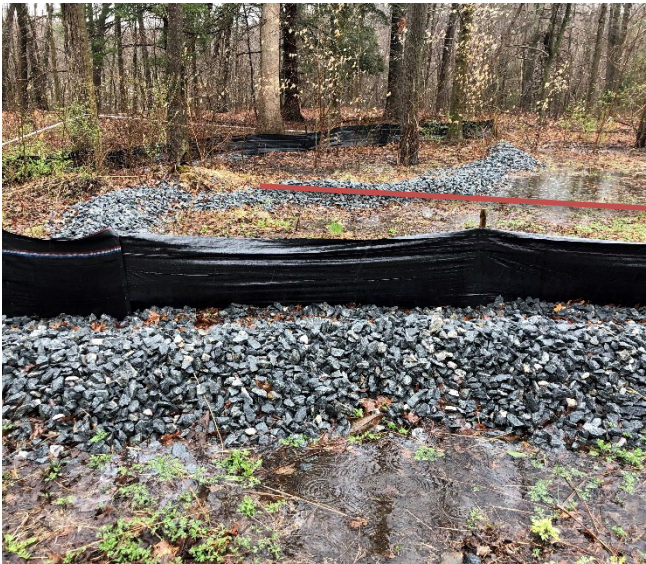
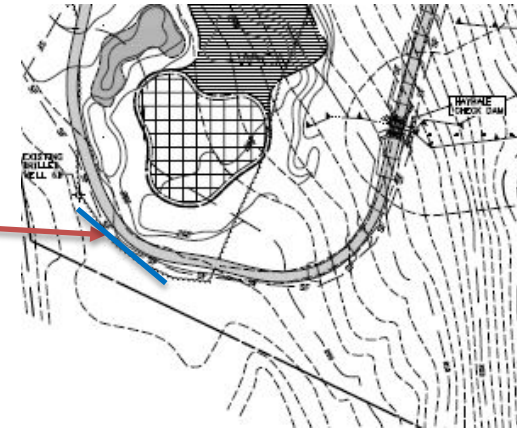
7. 14 th Hole Green Sediment Barriers	<input type="checkbox"/> Yes <input checked="" type="checkbox"/> No	<input type="checkbox"/> Yes <input checked="" type="checkbox"/> No		Additional stone check dams and sediment fence are in good condition (Photo 9).

Photo 9: Sediment fence has been repaired and additional stone check dams added to disrupt flows. Measures are in good condition and flow is filtered by stone check dams.

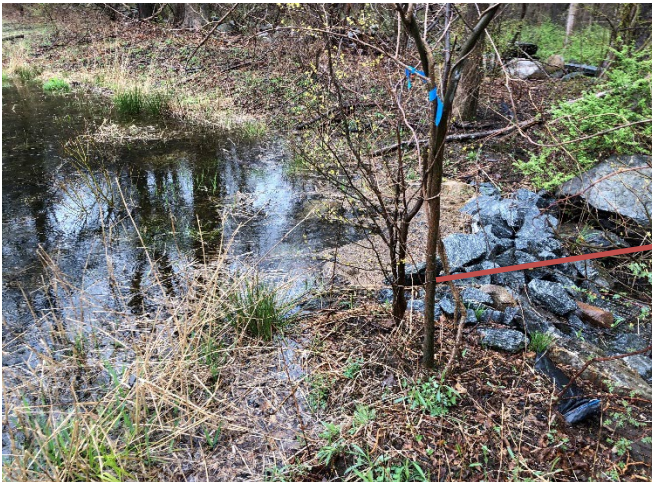
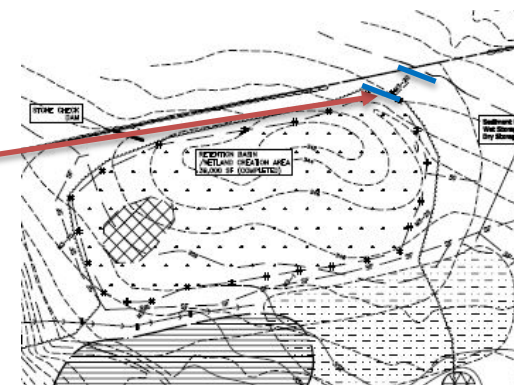
8. Created Wetlands Outlet	<input type="checkbox"/> Yes <input checked="" type="checkbox"/> No	<input type="checkbox"/> Yes <input checked="" type="checkbox"/> No		No repairs required. Discharge from wetlands was flowing clear (Photo 10).

Photo 10: Clear flow from wetlands outlet.
