Name of Project	Franklin Hills Estates & Country Club	CGP Tracking No.	IR #20-10	Inspection Date	12/10/2020
Inspector Name, Title & Contact Information	Inspector: Jacob Faulise, E.I.T.		Reviewer: David McKay, P.E.		
Present Phase of Construction	Phase 1				
Inspection Location (if multiple inspections are required, specify location where this inspection is being conducted)	Areas of Concern as defined at site walk with wetlands commission				
<p>Inspection Frequency (Note: you may be subject to different inspection frequencies in different areas of the site. Check all that apply.)</p> <p>Standard Frequency: <input type="checkbox"/> Weekly <input type="checkbox"/> within 24 hours of a 0.5" rain</p> <p>Increased Frequency: <input type="checkbox"/> Every 7 days and within 24 hours of a 0.5" rain (for areas of sites discharging to sediment or nutrient-impaired waters or to waters designated as Tier 2, Tier 2.5, or Tier 3)</p> <p>Reduced Frequency:</p> <ul style="list-style-type: none"> - <input checked="" type="checkbox"/> Once per month (for stabilized areas) - <input type="checkbox"/> Once per month and within 24 hours of a 0.5" rain (for arid, semi-arid, or drought-stricken areas dur

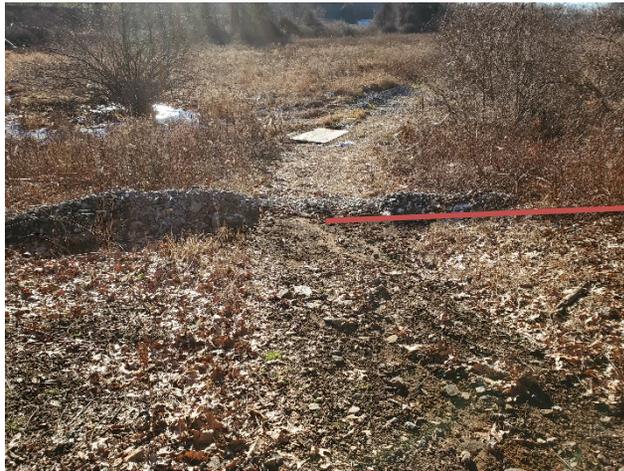
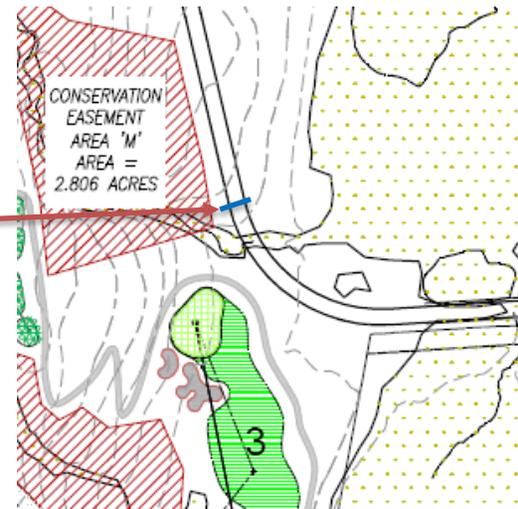
1. Main Entry Water Crossing (Northerly of 3 rd Hole Green)	<input checked="" type="checkbox"/> Yes <input type="checkbox"/> No	<input type="checkbox"/> Yes <input checked="" type="checkbox"/> No		Stone check dam immediately upgradient of crossing has been partially flattened due to trespassing ATVs and has reached full capacity (Photo 1). Stone check dam in trail leading down to crossing has reached capacity (Photo 2). Both check dams need accumulated sediment removed and minor repair.

Photo 1: Stone check dam immediately upgradient of main entry water crossing has flattened due to ATV traffic and has reached capacity with collected sediment.

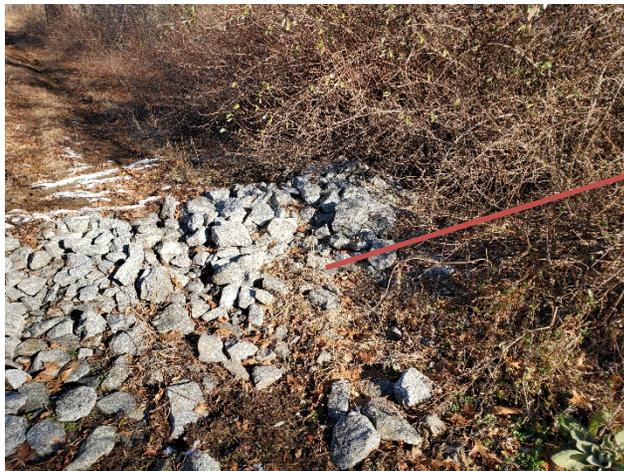
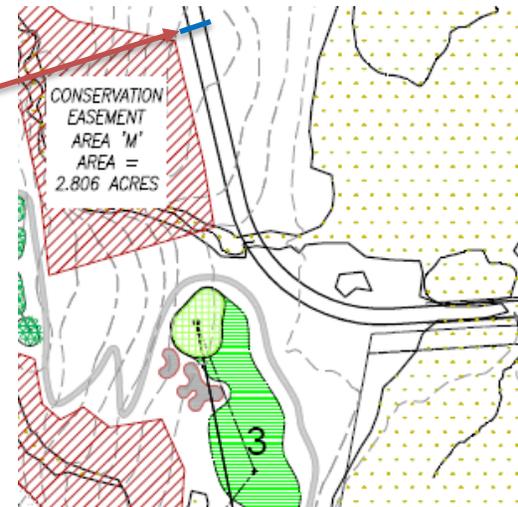
Photo 2: Stone check dam in path leading to water crossing has reached capacity and allowed sediment to flow around check dam.

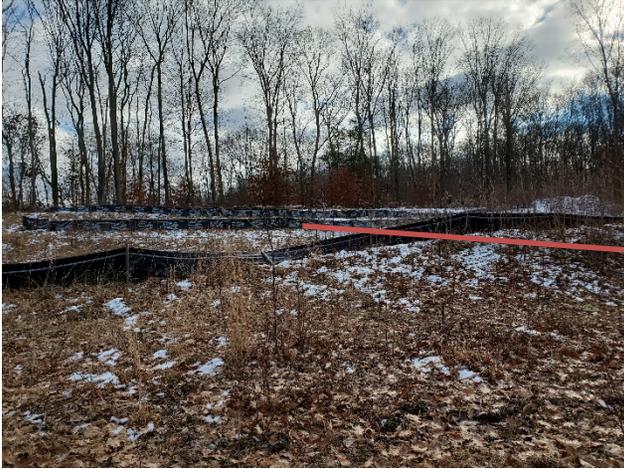
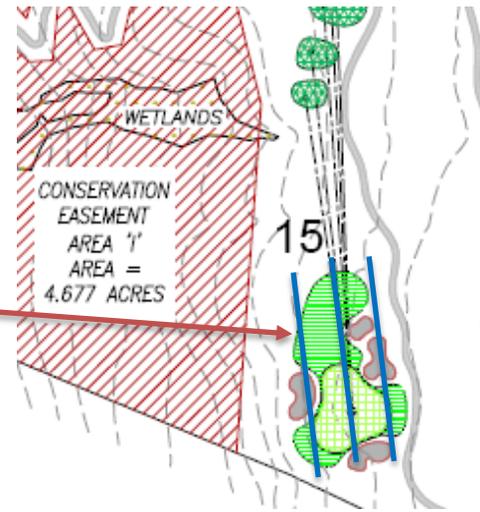
2. 15 th Green Sediment Barriers	<input checked="" type="checkbox"/> Yes <input type="checkbox"/> No	<input type="checkbox"/> Yes <input checked="" type="checkbox"/> No		Stone check dams and sediment fence rows across 15 th Hole green remain in good condition overall (Photo 3). Sediment fence rows and staked hay bales in one area have deteriorated and need to be replaced (Photo 4). Downgradient stone check dam remains in good condition. Sediment fence along tree line has undermined in two locations and should be repaired.

Photo 3: Sediment fence and stone check dams installed across the 15th hole green remain in good condition overall and are functioning as intended with ample storage capacity available.

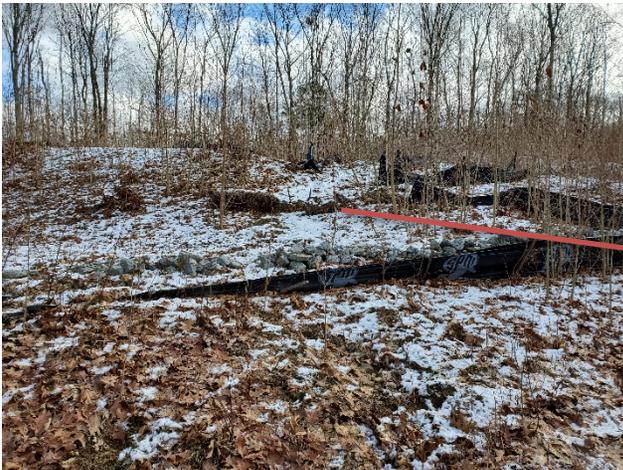
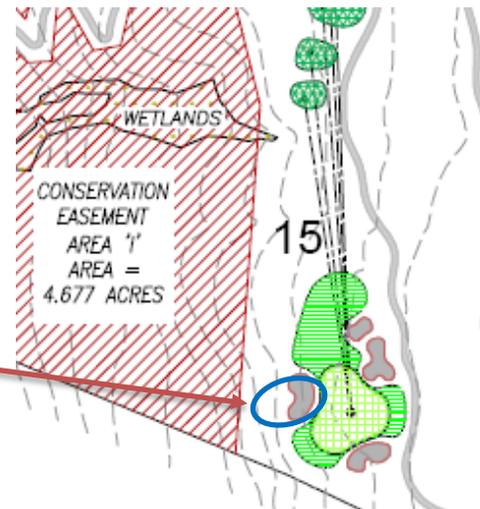
Photo 4: Staked hay bales and sediment fence in area shown have failed/deteriorated. Stone check dam downgradient remains in good condition with ample storage capacity available.

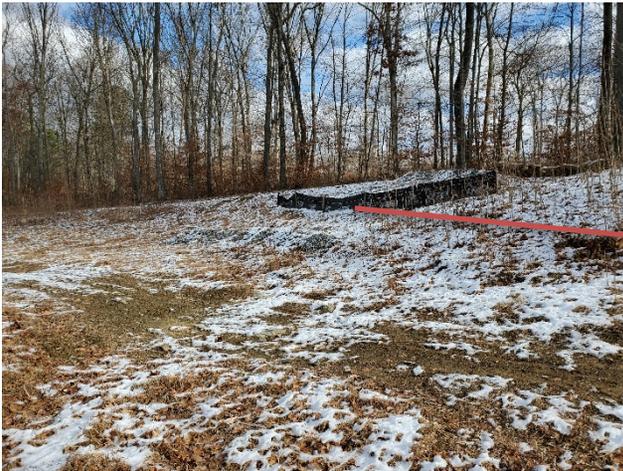
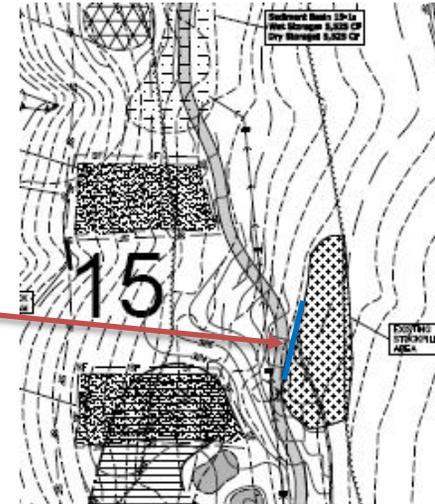
3. 15 th Fairway Sediment Barriers	<input type="checkbox"/> Yes <input checked="" type="checkbox"/> No	<input type="checkbox"/> Yes <input checked="" type="checkbox"/> No		Stone check dams, stone apron, staked hay bales, and sediment fence are all in good condition and functioning as intended with ample storage available (Photo 5).

Photo 5: Stone check dams, staked hay bales, and sediment fence remain in good condition with ample storage capacity available.

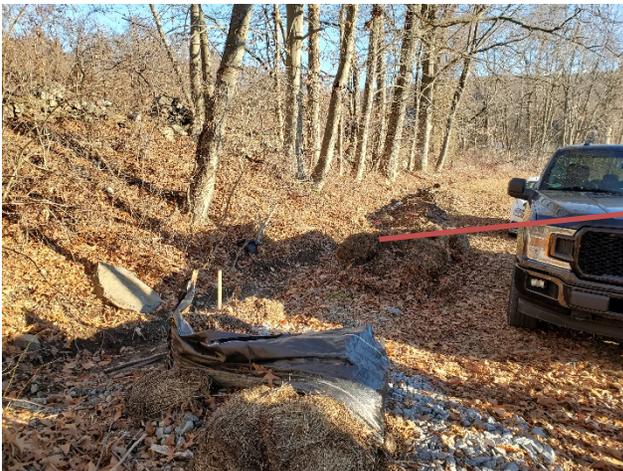
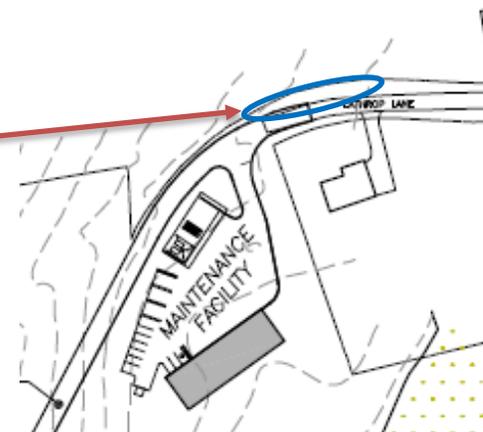
4. Construction Entrance (Westerly of Proposed Maintenance Road)	<input checked="" type="checkbox"/> Yes <input type="checkbox"/> No	<input type="checkbox"/> Yes <input checked="" type="checkbox"/> No		Stone check dam and water bar across construction entrance are in good condition and functioning. Staked hay bales and sediment fence are deteriorating and have been removed from flow path (Photo 6). Stone check dams should be added to new swale if erosion occurs.

Photo 6: Staked hay bales and sediment fence at construction entrance have deteriorated and been removed since last inspection.

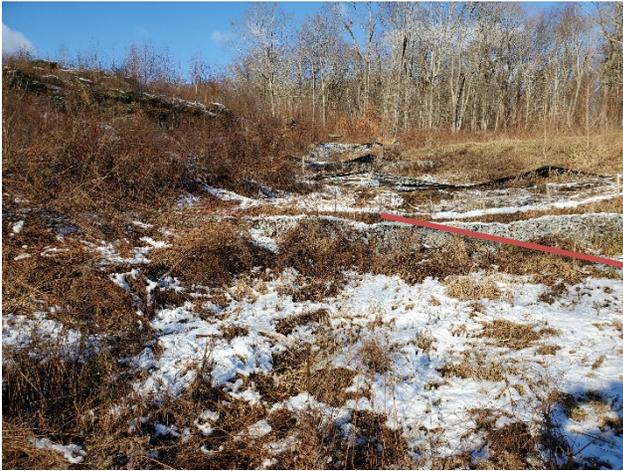
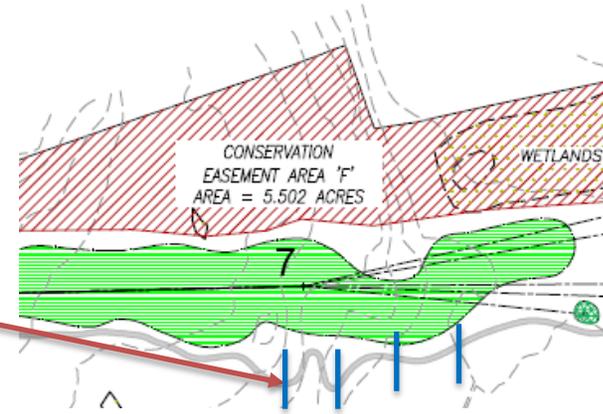
5. 7 th Hole Fairway Hillside	<input type="checkbox"/> Yes <input checked="" type="checkbox"/> No	<input type="checkbox"/> Yes <input checked="" type="checkbox"/> No		Sediment fence rows and check dams across 7 th Hole fairway are in good condition overall and functioning as intended with ample storage capacity available (Photo 7). Sediment fence has failed in several locations but remaining sediment barriers have area contained.

Photo 7: Stone check dams, sediment fence rows, and staked hay bales across the 7th hole fairway hillside remain in good condition and are functioning as intended with ample storage capacity available.

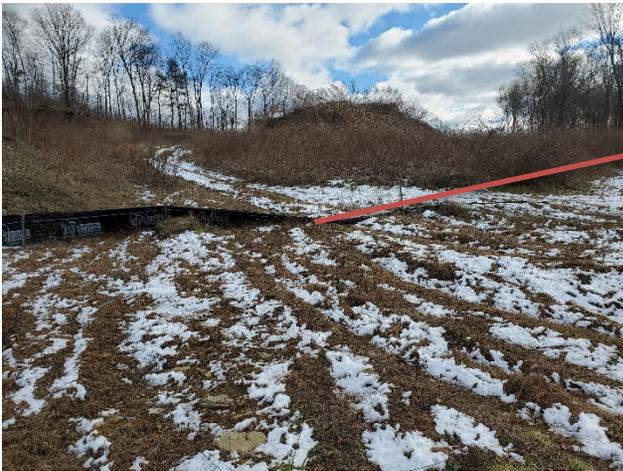
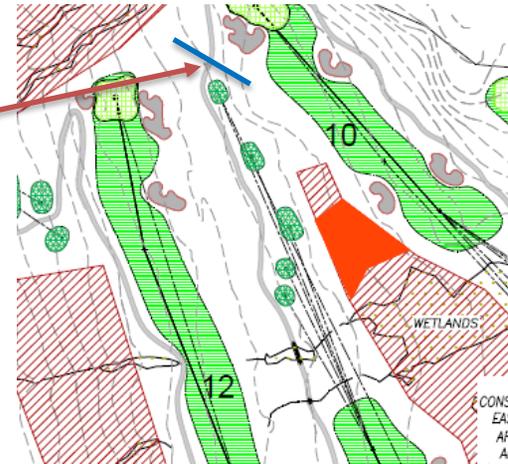
6. 11 th Hole Tee Box Area	<input type="checkbox"/> Yes <input checked="" type="checkbox"/> No	<input type="checkbox"/> Yes <input checked="" type="checkbox"/> No		Sediment fence row across path by 11 th Hole tee box has failed due to ATV traffic (Photo 8). At time of inspection the area was stable.

Photo 8: Sediment fence row across 11th hole tee box area has been knocked over by ATV traffic but area was stable at time of inspection.

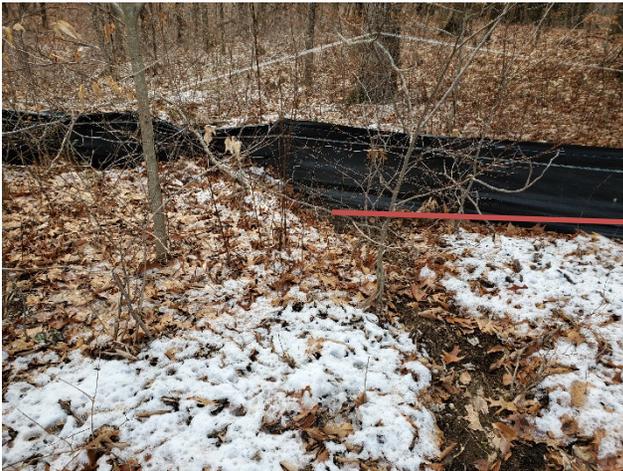
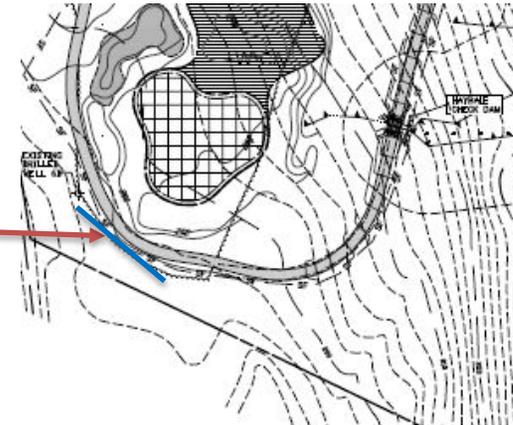
7. 14 th Hole Green Sediment Barriers	<input checked="" type="checkbox"/> Yes <input type="checkbox"/> No	<input type="checkbox"/> Yes <input checked="" type="checkbox"/> No		Sediment fence row at tree line is allowing flow underneath in one location and needs to be corrected (Photo 9).

Photo 9: Sediment fence at tree line by 14th hole is allowing flow underneath in one location and needs to be repaired.

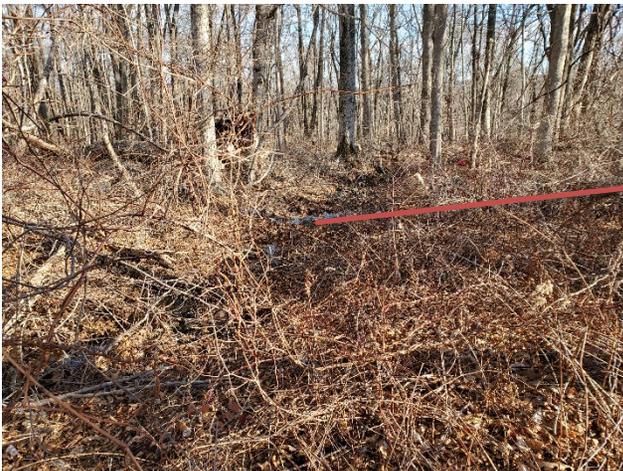
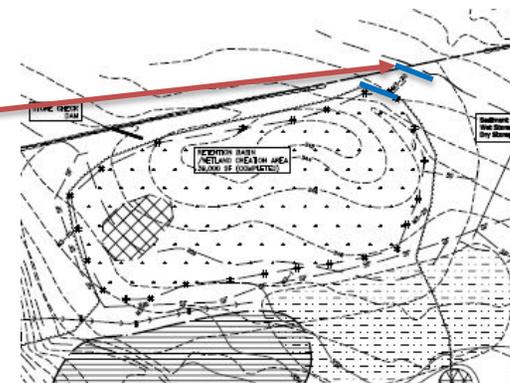
8. Created Wetlands Outlet	<input checked="" type="checkbox"/> Yes <input type="checkbox"/> No	<input type="checkbox"/> Yes <input checked="" type="checkbox"/> No		Stone check dam at outlet of created wetlands remains in good condition and is functioning as intended. Check dam downgradient needs to be replaced (Photo 10).

Photo 10: Stone check dam downgradient from created wetlands outlet is no longer functioning as intended and should be replaced.
