| Name of Project | Franklin Hills Estates & Country Club | CGP Tracking No. | IR #20-10 | Inspection Date | 1/27-28/2021 |
| Present Phase of Construction | Phase 1 | | | | |
| Inspection Location (if multiple inspections are required, specify location where this inspection is being conducted) | Areas of Concern as defined at site walk with wetlands commission | | | | |

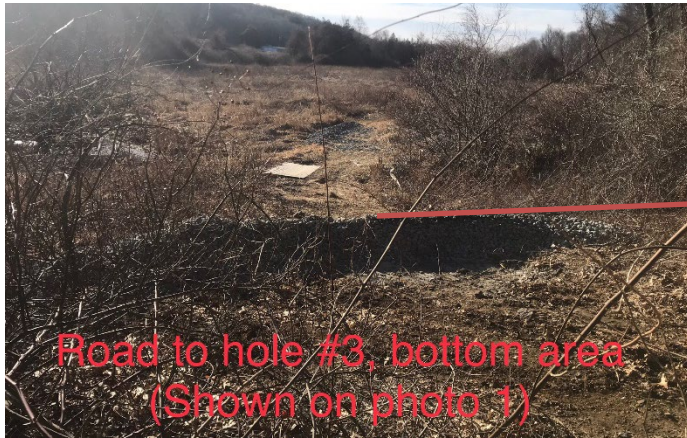
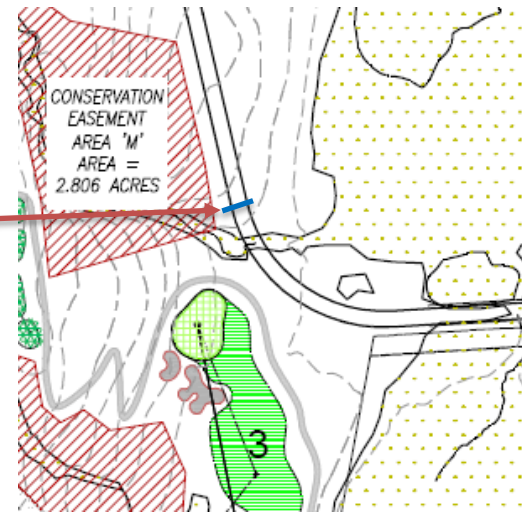
| Type/Location of E&S Control | Repairs or Other Maintenance Needed?* | Corrective Action Required?* | Date on Which Maintenance or Corrective Action First Identified? | Notes |
|--|---|---|--|--|
| 1. Main Entry Water Crossing (Northerly of 3 rd Hole Green) | <input type="checkbox"/> Yes <input checked="" type="checkbox"/> No | <input type="checkbox"/> Yes <input checked="" type="checkbox"/> No | | Stone check dam immediately upgradient of crossing has been replaced and has ample storage capacity (Photo 1). Stone check dam in trail leading down to crossing has been replaced and has ample storage capacity (Photo 2). An additional check dam has been added. |

Photo 1: Stone check dam immediately upgradient of main entry water crossing has been repaired.

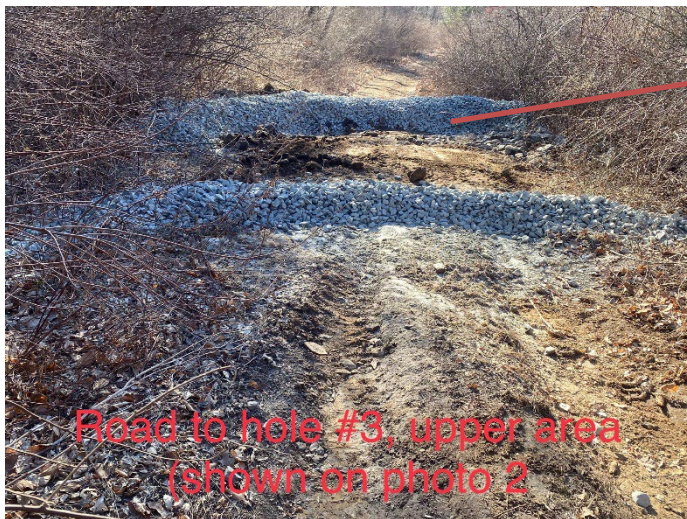
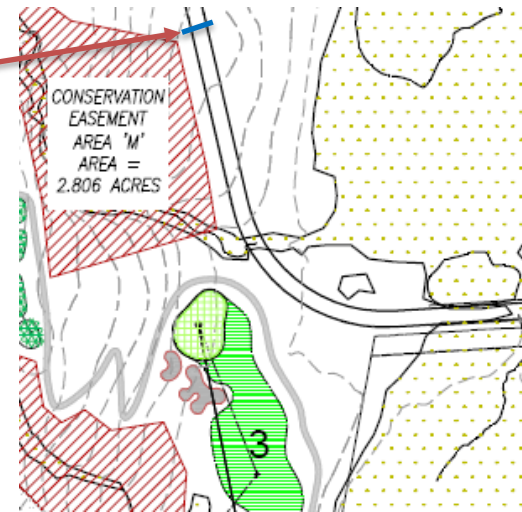
Photo 2: Stone check dam in path leading to water crossing has been repaired and an additional check dam has been added.

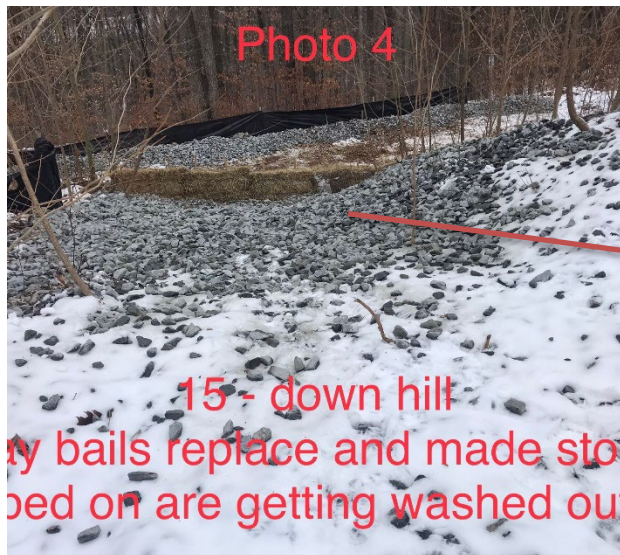
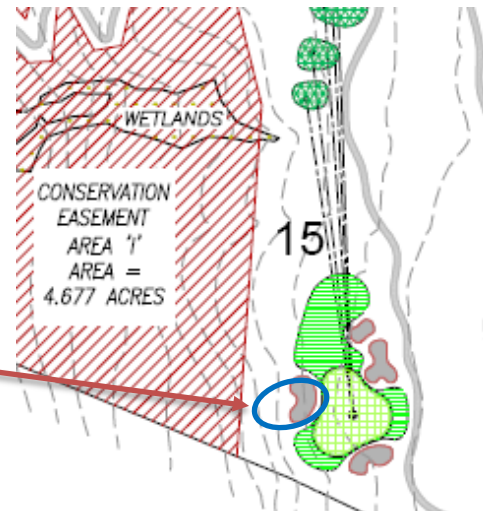
| Type/Location of E&S Control | Repairs or Other Maintenance Needed?* | Corrective Action Required?* | Date on Which Maintenance or Corrective Action First Identified? | Notes |
|--|---|---|--|--|
| 2. 15 th Green Sediment Barriers | <input type="checkbox"/> Yes <input checked="" type="checkbox"/> No | <input type="checkbox"/> Yes <input checked="" type="checkbox"/> No | | Downgradient stone check dam remains in good condition. Sediment fence along the cart path and along the tree line have been repaired and reinforced with stone check dams. Intermediate sediment fence has been re-staked. (Photo 3). Sediment fence rows and staked hay bales in south end have been repaired and eroded area has been stabilized with stone. (Photo 4). |

Photo 4: Staked hay bales have been replaced and eroded area has been stabilized with stone.

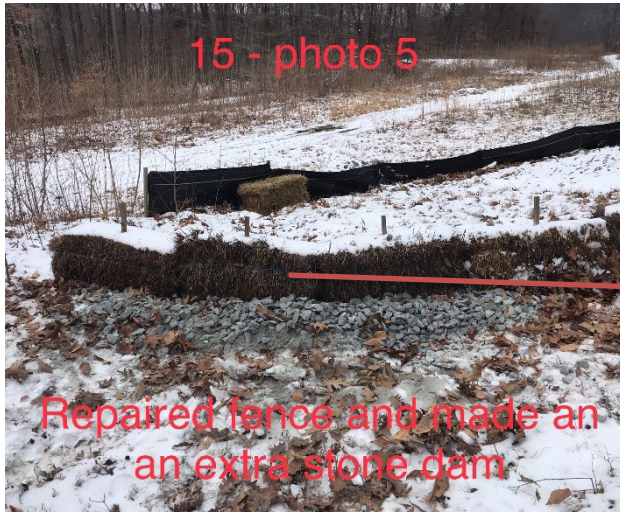
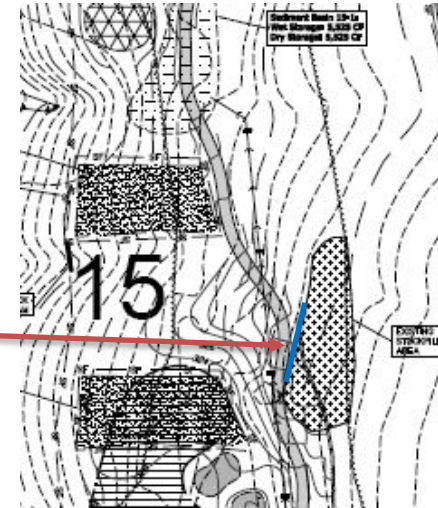
| Type/Location of E&S Control | Repairs or Other Maintenance Needed?* | Corrective Action Required?* | Date on Which Maintenance or Corrective Action First Identified? | Notes |
|--|---|---|--|--|
| 3. 15 th Fairway Sediment Barriers | <input type="checkbox"/> Yes <input checked="" type="checkbox"/> No | <input type="checkbox"/> Yes <input checked="" type="checkbox"/> No | | Stone check dams, stone apron are in good condition and functioning as intended. Sediment fence has been repaired and reinforced with additional stone check dam (Photo 5). |

Photo 5: Stone check dams and staked hay bales are in good condition. Sediment fence has been repaired and an additional stone check dam has been added.

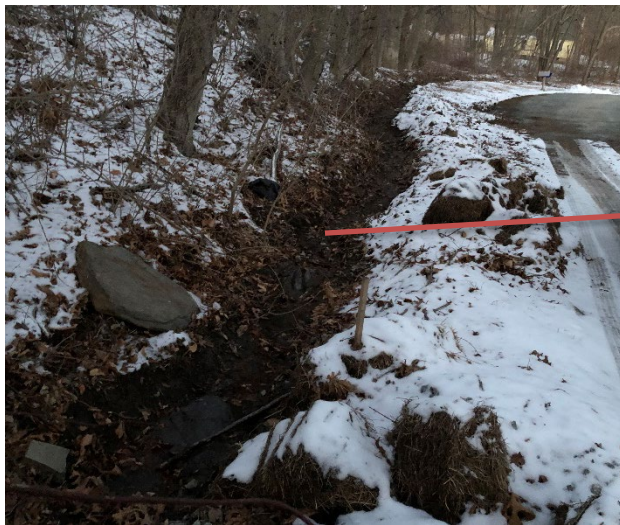
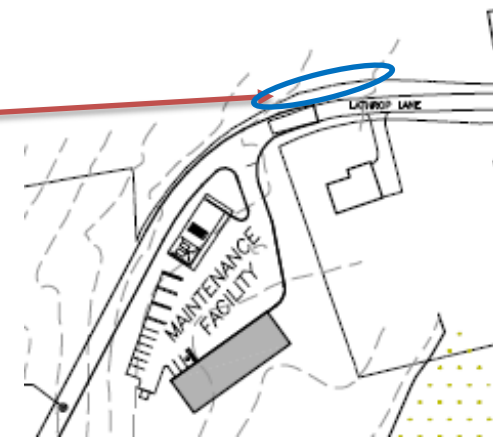
| Type/Location of E&S Control | Repairs or Other Maintenance Needed?* | Corrective Action Required?* | Date on Which Maintenance or Corrective Action First Identified? | Notes |
|--|---|---|--|--|
| 4. Construction Entrance (Westerly of Proposed Maintenance Road) | <input type="checkbox"/> Yes <input checked="" type="checkbox"/> No | <input type="checkbox"/> Yes <input checked="" type="checkbox"/> No | | Stone check dam and water bar across construction entrance are in good condition and functioning. Staked hay bales and sediment fence are deteriorating and have been removed from flow path (Photo 6). Diversion swale excavated to downgradient drainage structure does not show signs of erosion. Stone check dams should be added to new swale if erosion occurs. |

Photo 6: Recently constructed swale carrying flow to downgradient drainage structure. No signs of erosion in swale.

| Stabilization Area | Stabilization Method | Have You Initiated Stabilization? | Notes |
|--|---|--|---|
| 1. Construction Access Drive | Plans - Anti-tracking pad Existing - Water bar at site entrance | <input checked="" type="checkbox"/> Yes <input type="checkbox"/> No <input type="checkbox"/> N/A | There was little flow in the swale during the inspection with no evidence of erosion. Add stone check dams to swale if erosion occurs. |

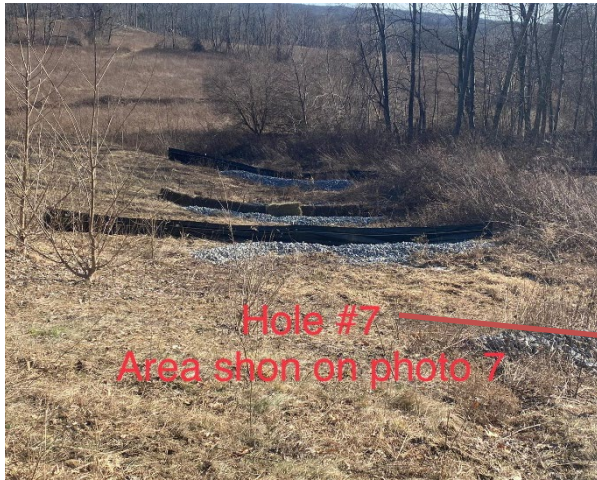
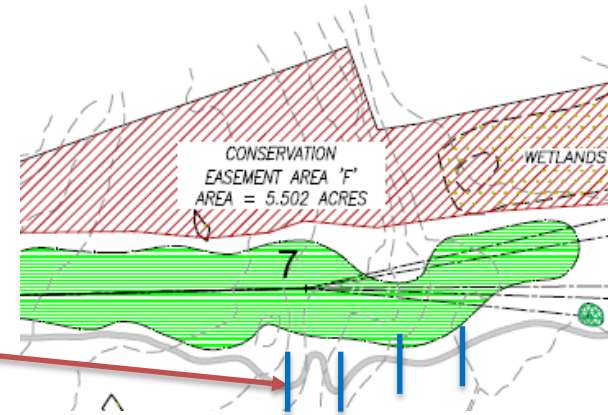
| Type/Location of E&S Control | Repairs or Other Maintenance Needed?* | Corrective Action Required?* | Date on Which Maintenance or Corrective Action First Identified? | Notes |
|--|---|---|--|--|
| 5. 7 th Hole Fairway Hillside | <input type="checkbox"/> Yes <input checked="" type="checkbox"/> No | <input type="checkbox"/> Yes <input checked="" type="checkbox"/> No | | Check dams across 7 th Hole fairway are in good condition overall and functioning as intended (Photo 7). Sediment fence has been repaired and reinforced with additional stone check dams. |

Photo 7: Stone check dams across the 7th hole fairway hillside remain in good condition. Sediment fence rows and hay bales have been repaired and reinforced with stone check dams.

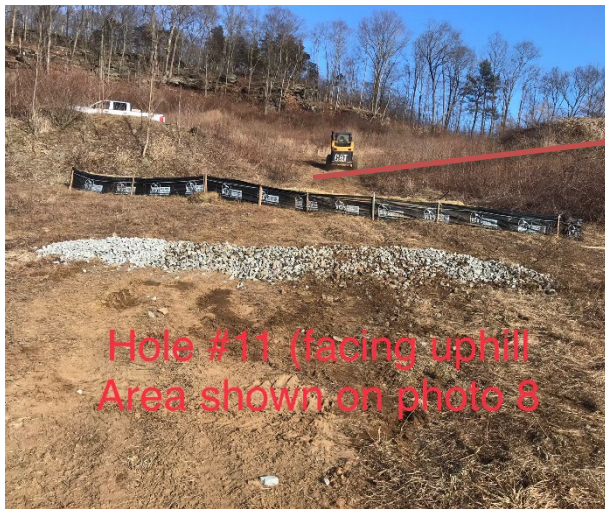
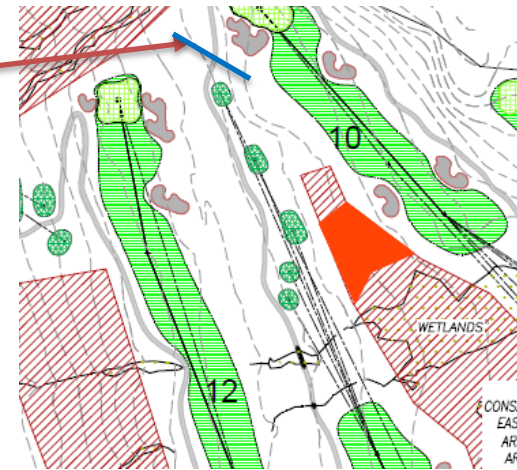
| Type/Location of E&S Control | Repairs or Other Maintenance Needed?* | Corrective Action Required?* | Date on Which Maintenance or Corrective Action First Identified? | Notes |
|--|---|---|--|--|
| 6. 11 th Hole Tee Box Area | <input type="checkbox"/> Yes <input checked="" type="checkbox"/> No | <input type="checkbox"/> Yes <input checked="" type="checkbox"/> No | | Sediment fence row across path by 11 th Hole tee box has been repaired and reinforced with an additional hay bale check dam (Photo 8). Stone check dam has been replaced. |

Photo 8: Sediment fence row across 11th hole tee box area has been repaired and stone check dam upgraded. A hay bale check dam has been added upgradient of the sediment fence.

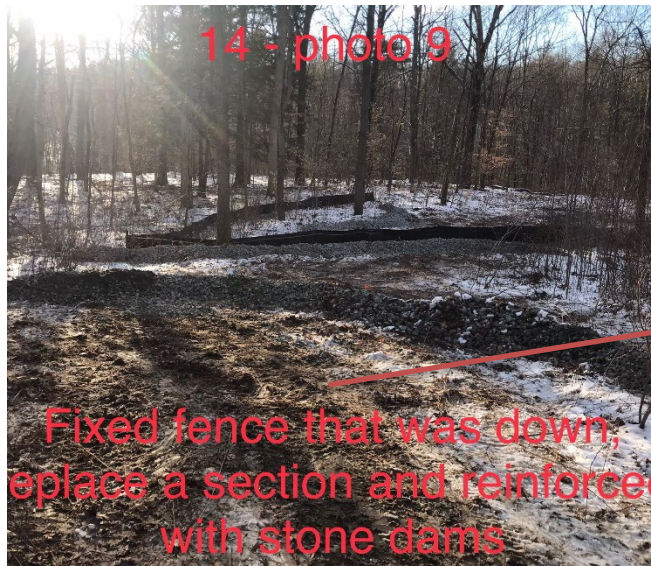
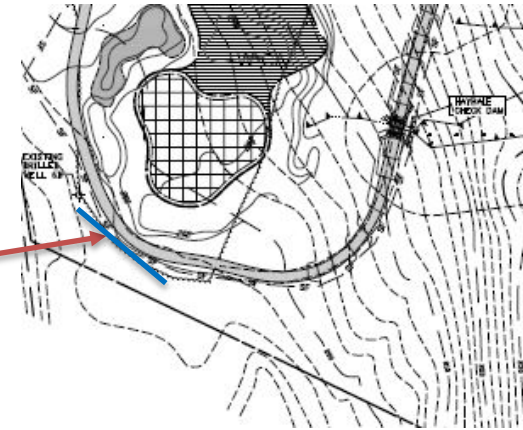
| Type/Location of E&S Control | Repairs or Other Maintenance Needed?* | Corrective Action Required?* | Date on Which Maintenance or Corrective Action First Identified? | Notes |
|--|---|---|--|--|
| 7. 14 th Hole Green Sediment Barriers | <input type="checkbox"/> Yes <input checked="" type="checkbox"/> No | <input type="checkbox"/> Yes <input checked="" type="checkbox"/> No | | Sediment fence row at tree line has been reinforced with an additional check dam (Photo 9). Additional stone check dams have been added upgradient of the sediment fence. |

Photo 9: Sediment fence has been repaired and additional stone check dams added to disrupt flows.
